***LIMITED PHASE II ENVIRONMENTAL SITE ASSESSMENT REPORT,
PROPOSED 17-ACRE MULTI-USE DEVELOPMENT INCLUDING OFFICE,
RETAIL AND CONDOMINIUMS, LOCATED AT FOOTHILL PARKWAY AND
WEST CHASE DRIVE, CITY OF CORONA, RIVERSIDE COUNTY, CALIFORNIA;
APNS: 275-050-014 AND 275-080-041.***

***Dated: November 30, 2020
Project No. G19-1802-15***

***Prepared For:
Mr. Chris Bowen
GF Investments, Inc.
110 North Lincoln Avenue, Suite 202
Corona, California 92882***

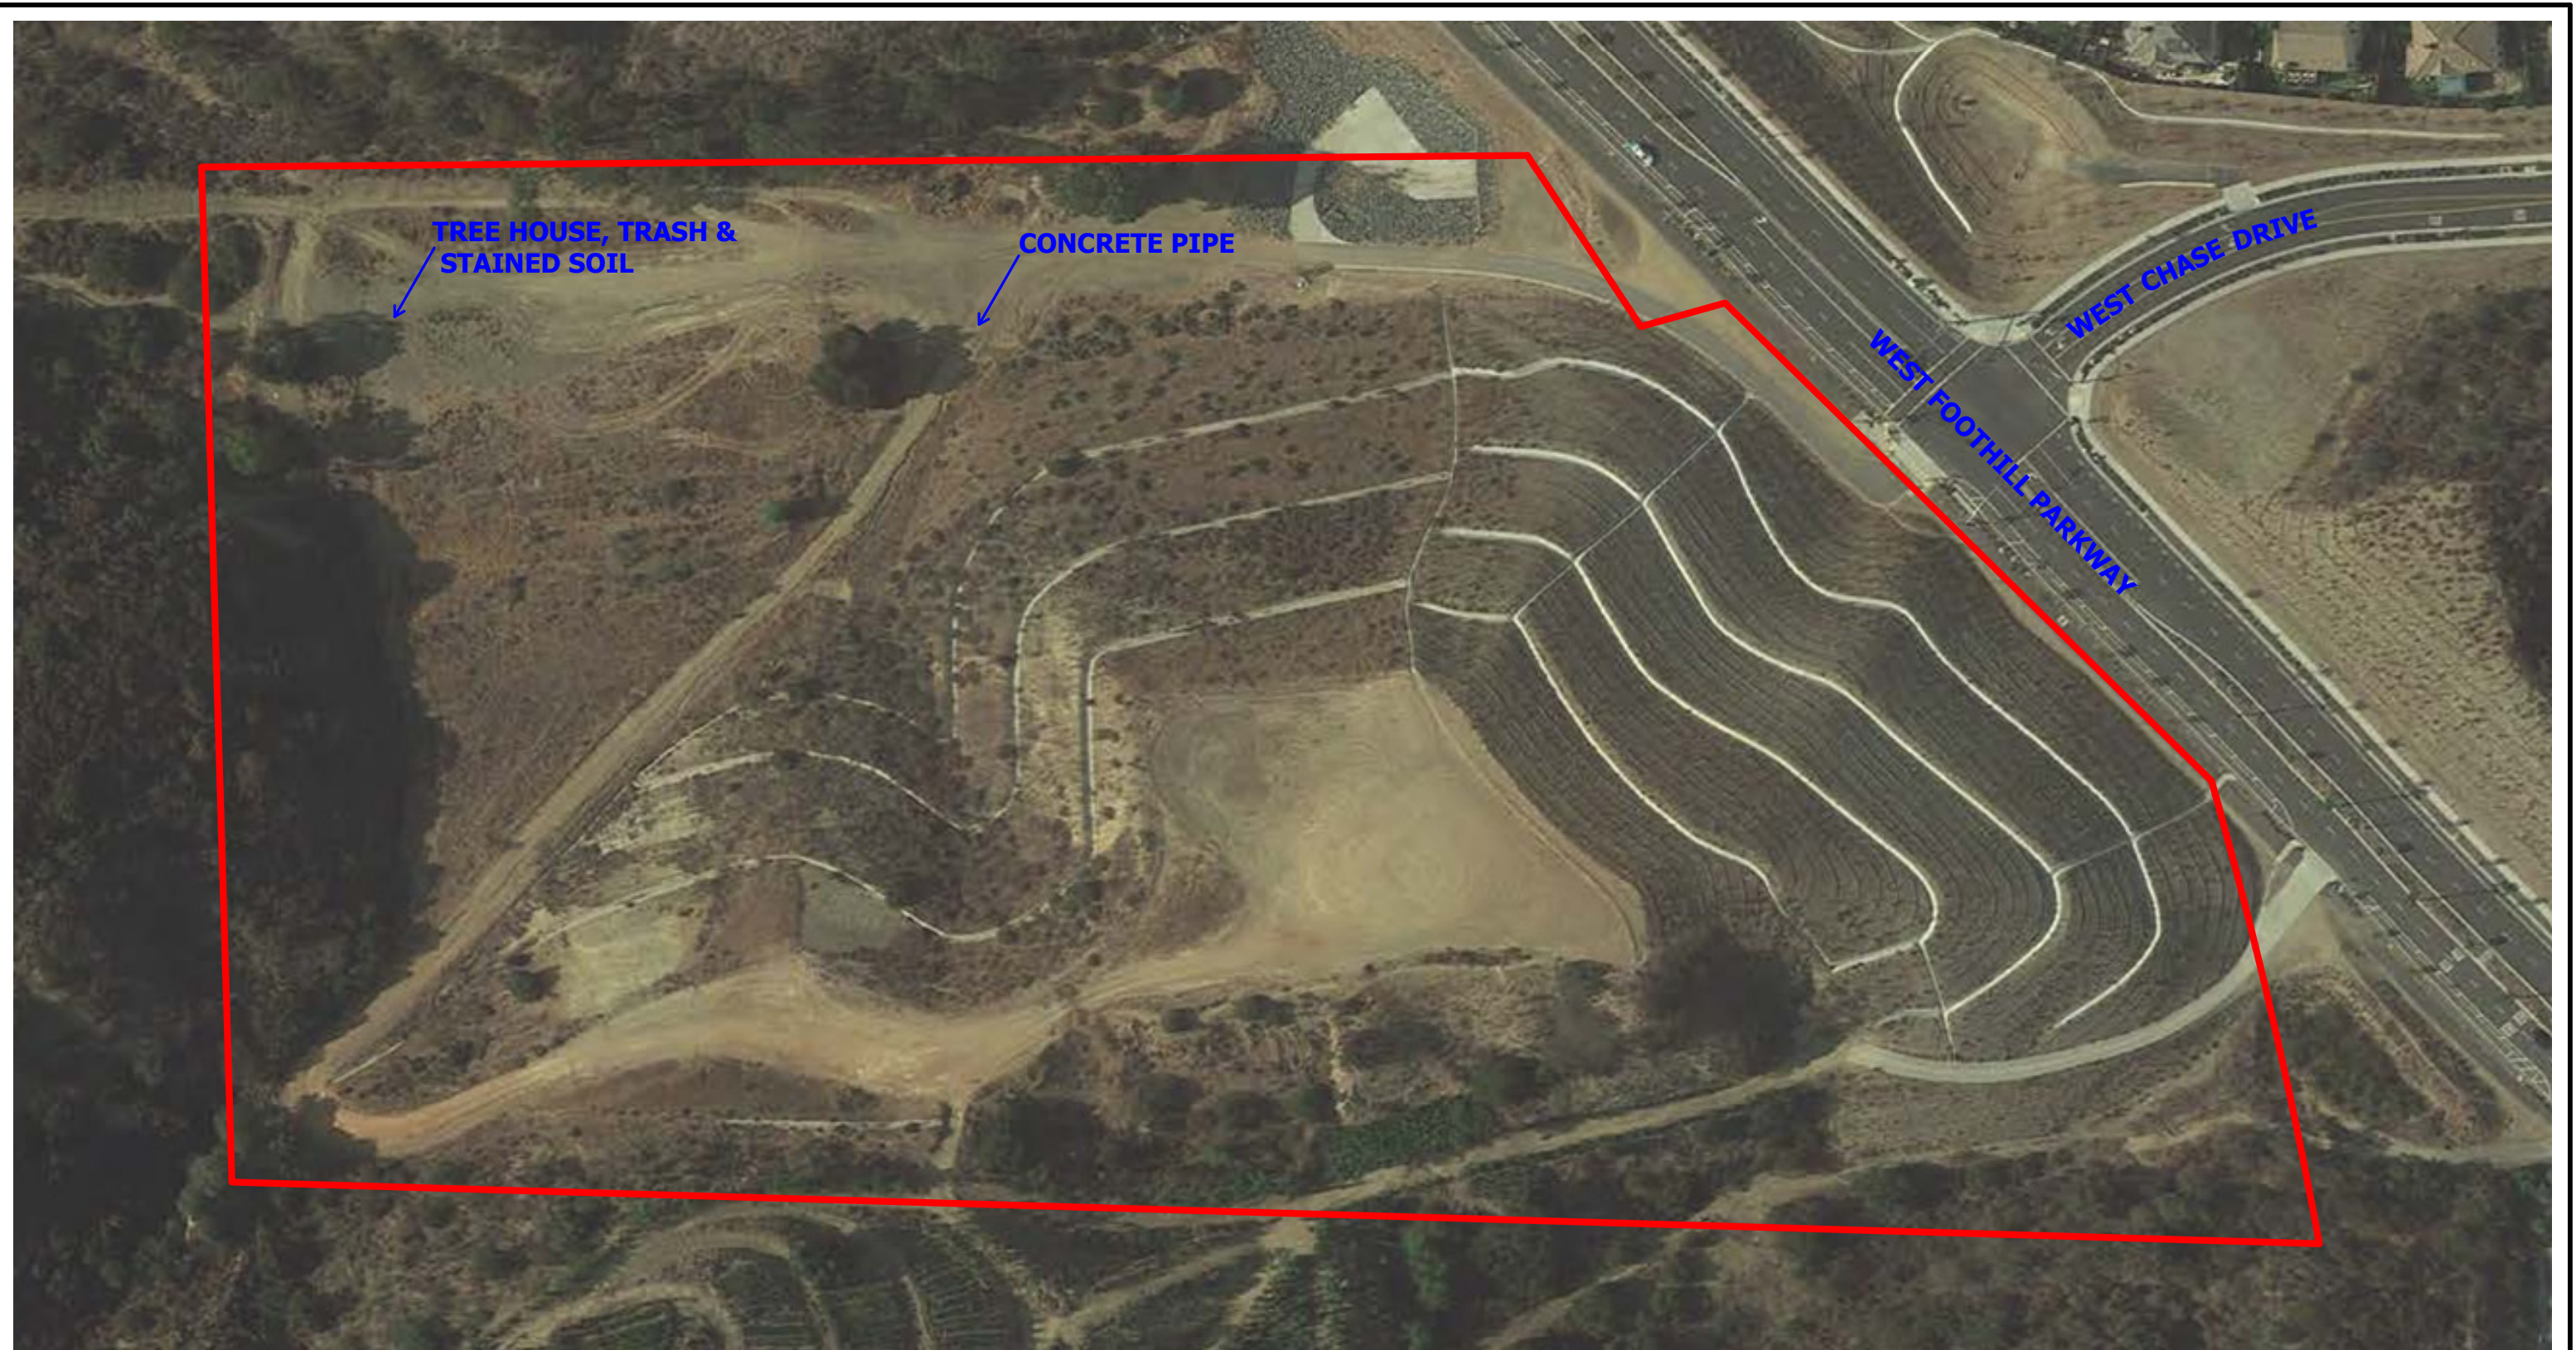
FIGURE 1 PROPERTY LOCATION MAP

Located along the southwest side of West Foothill Parkway opposite its 'T' intersection with West Chase Drive, the Property consists of two irregular-shaped parcels comprising a total of approximately 17.63 acres (Figure 1). In 2006, the Property was graded for proposed single-family residential development under permit, creating a large pad in the center flanked by a graded slope facing north and northwest. In 2015 and 2016, a large roadcut slope was graded on the northeast portion of the Property for improvement/paving of West Foothill Parkway. The Property is bounded on the northeast by West Foothill Parkway followed by single-family residential parcels and West Chase Drive, on the north and west by vacant parcels, and on the south by a nursery parcel and a vacant parcel.

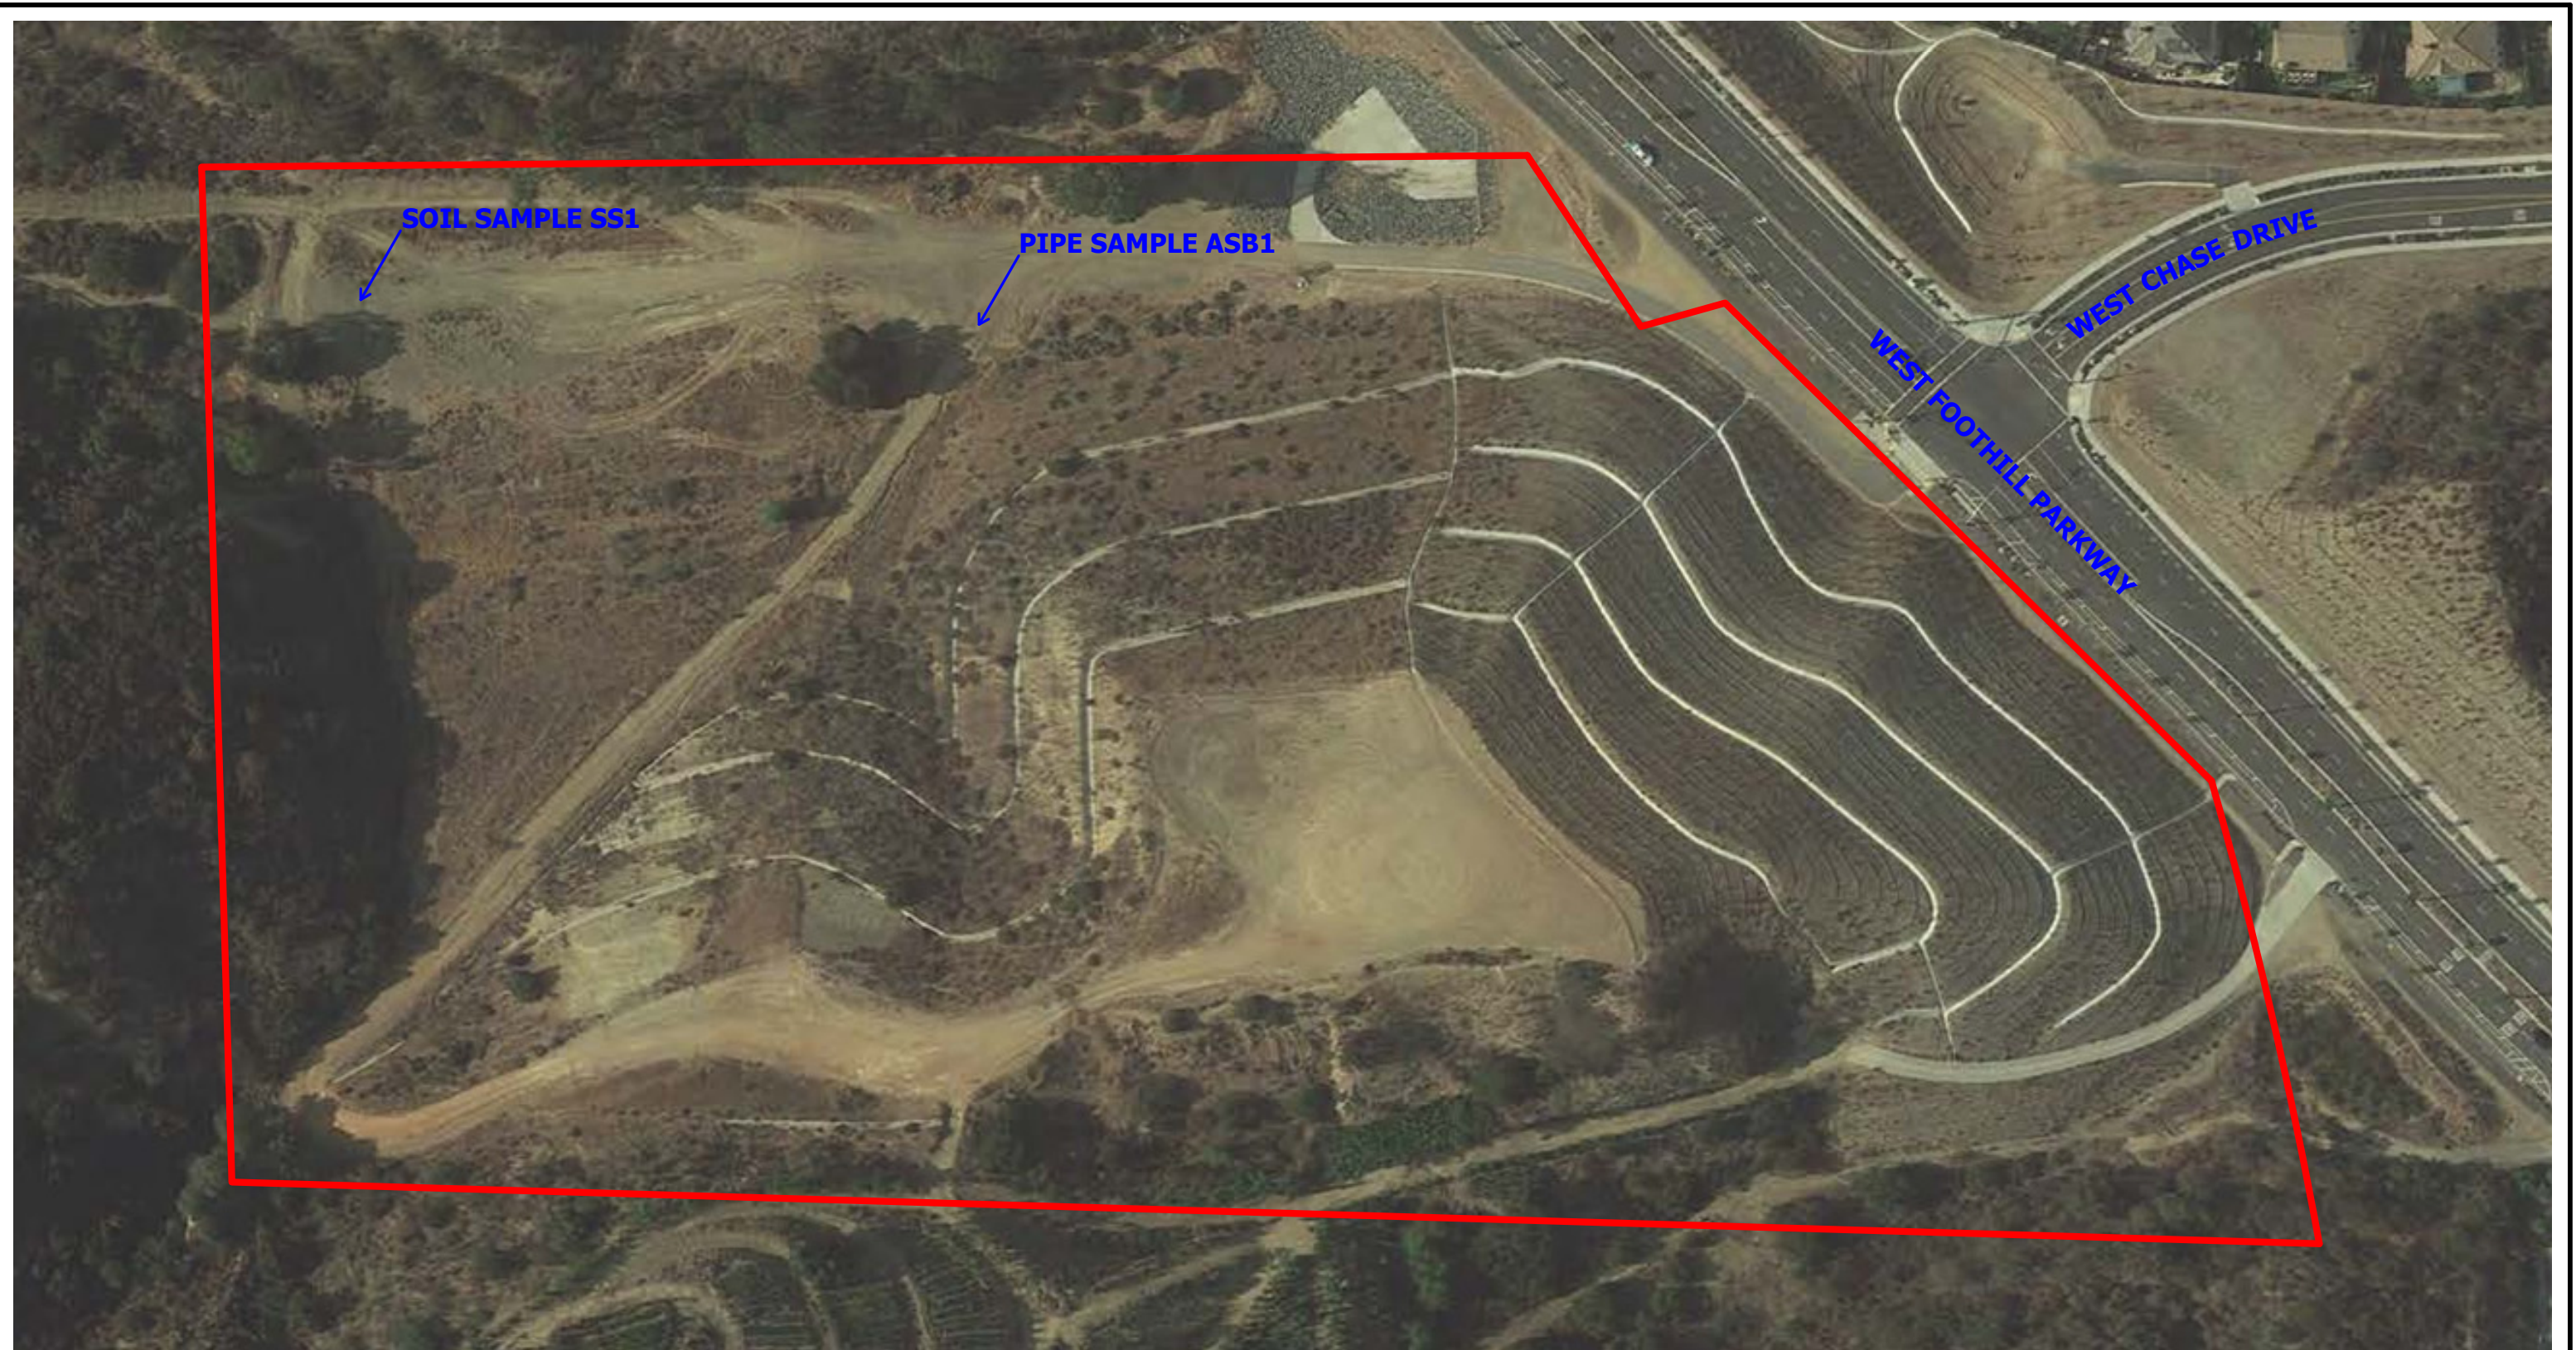
FIGURE 2 SAMPLE LOCATION MAP

On November 13, 2020, LGC collected one concrete pipe sample (ASB1) and one surface soil sample (SS1). The concrete pipe sample was manually collected directly into a zip-lock plastic sample bag, and the soil sample was manually collected directly into a glass sample jar. Approximate sample locations are depicted on Figure 2.

- In concrete pipe sample ASB1, the "None Detected" asbestos analytical results are less than the TTLC (1 percent). This indicates that the associated pipe is not an asbestos-containing material (ACM).
- In surface soil sample SS1, analytical results for TPH in the gasoline, diesel and motor oil ranges exceed the applicable ESL-Rs. This indicates that the associated stained soil is a petroleum-contaminated waste.

- The concrete pipe associated with sample ASB1 is not an ACM. Therefore, the concrete pipe can be properly disposed of or recycled as ordinary non-hazardous solid waste.
- The stained surface soil associated with surface soil sample SS1 is a petroleum-contaminated waste. Therefore, the stained soil should be excavated and properly disposed of or recycled. After excavation of the stained soil, the excavation should be sampled to confirm satisfactory removal of the petroleum-contaminated soil.

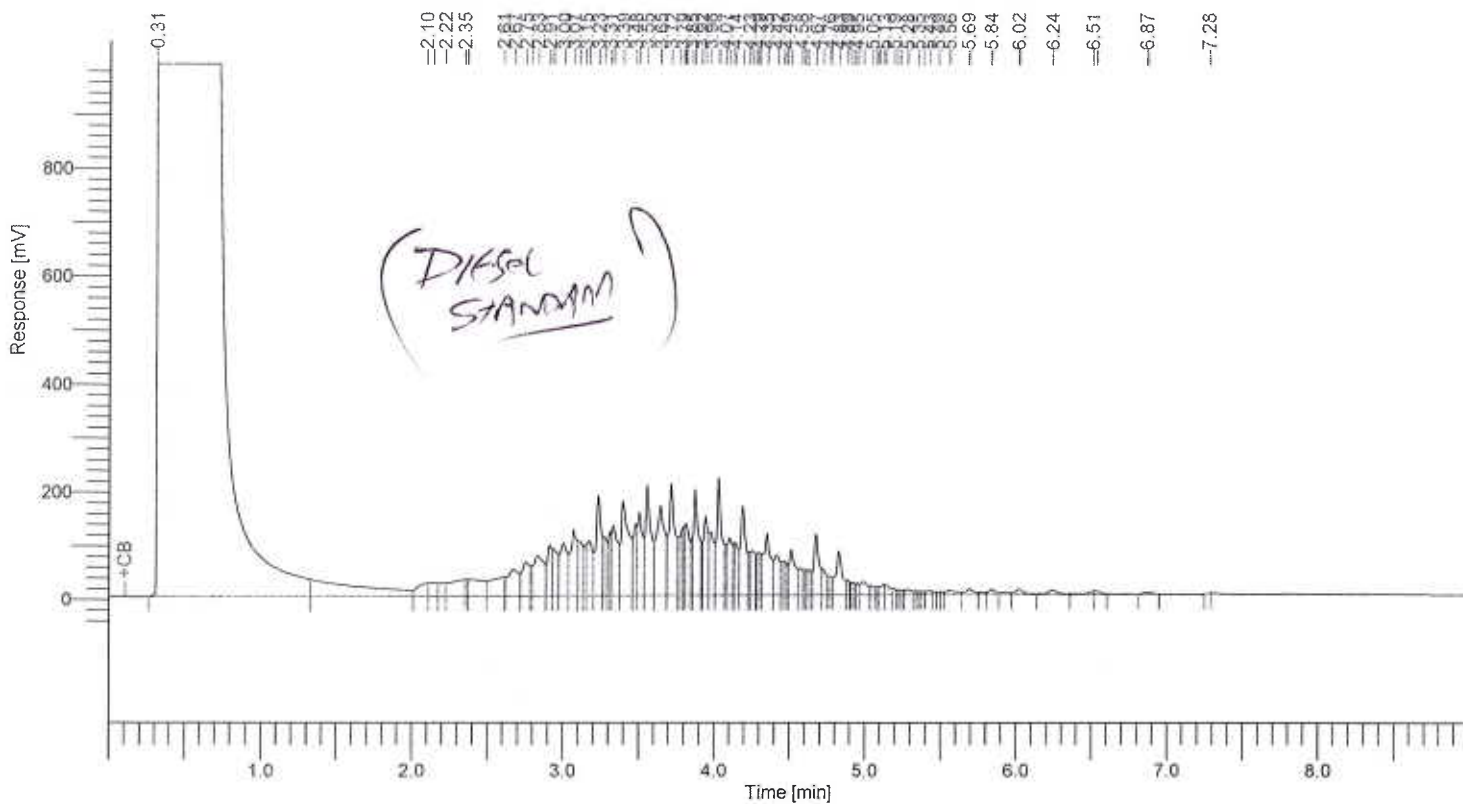
Software Version : 8.3.2.0046
 Sample Name : DIESEL CCV 2000PPM (GC-3900)
 Instrument Name : GC-1
 Rack/Vial : 03
 Sample Amount : 1.000000
 Cycle : 4

8015 Results
