**JURISDICTIONAL DELINEATION
FOR TTM 34760 IN THE
CITY OF CORONA,
RIVERSIDE COUNTY, CALIFORNIA**

July 31, 2009

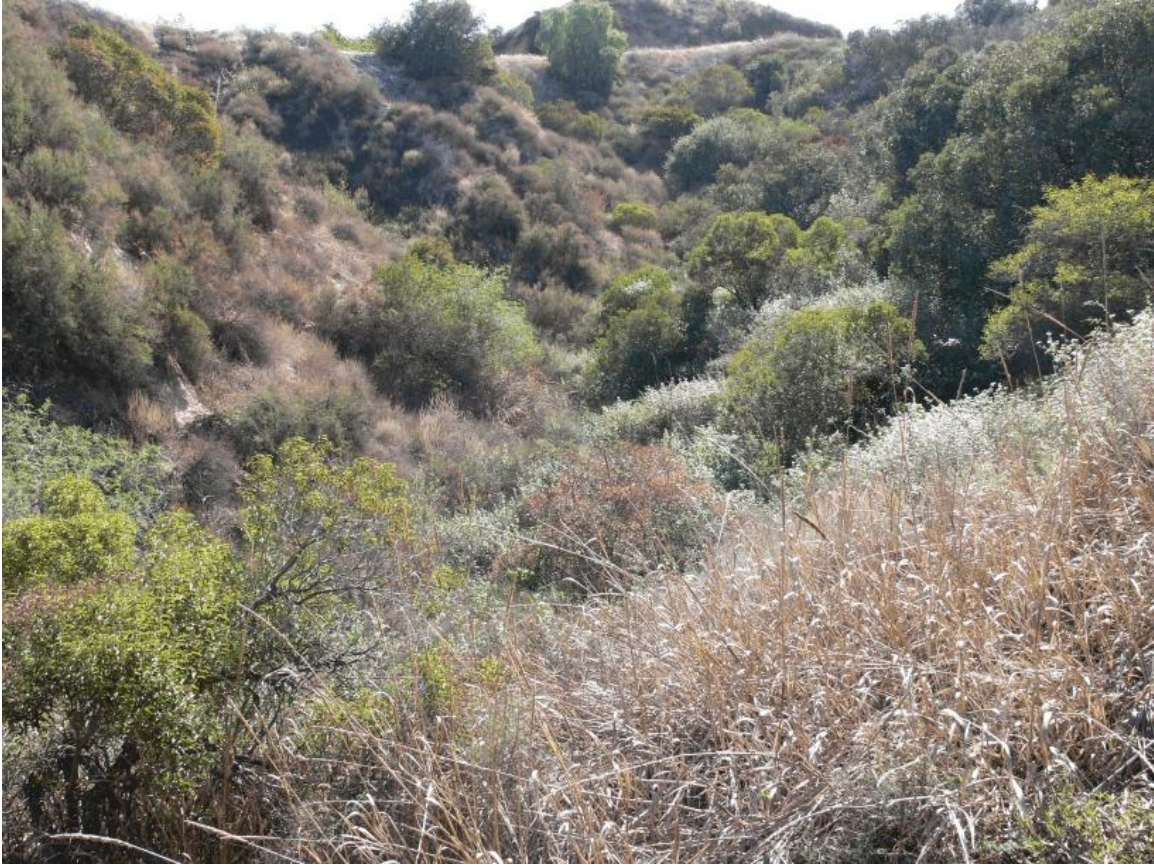
Drain A (photo 1): Looking to the southeast from near the patch of mule fat towards the head of the drainage.

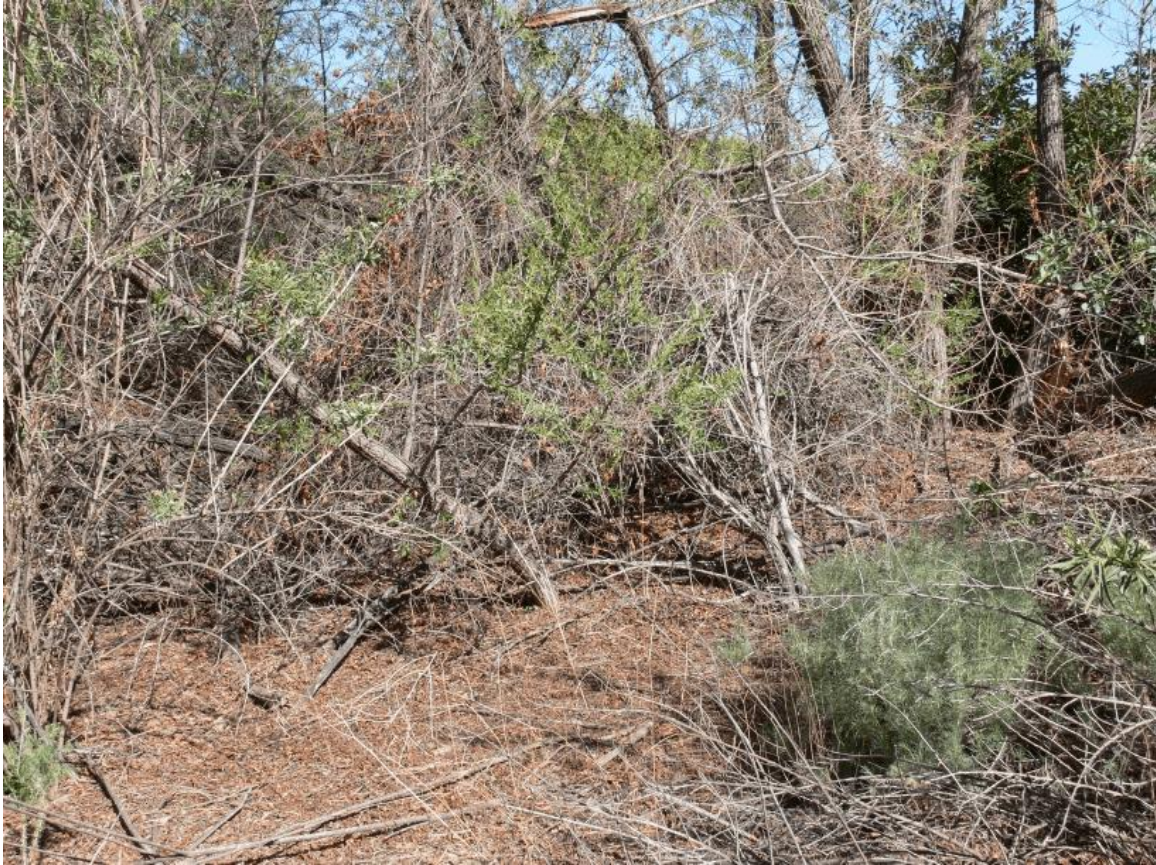
Drain A (photo 2): Looking north through the mule fat with the willow tree in the background.

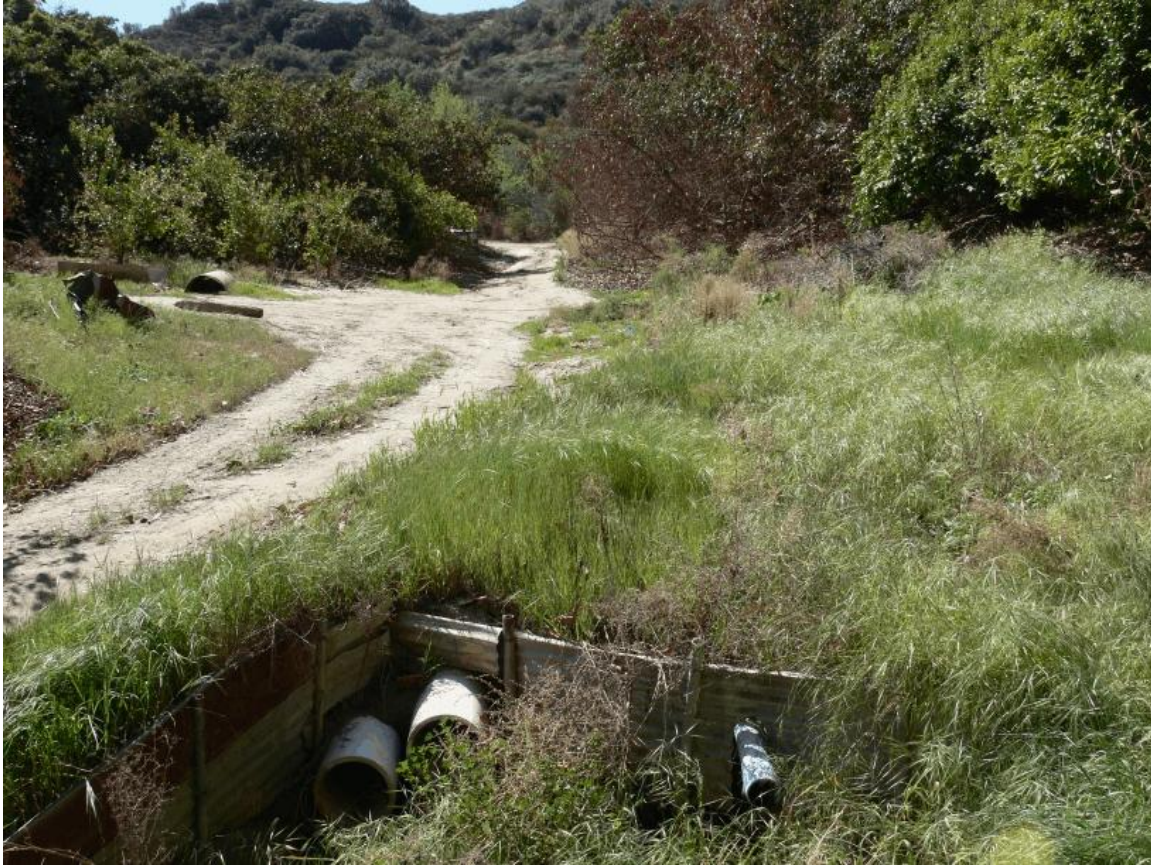
Drain A (photo 3): Looking south at point where pipes from willow tree daylight. Willow tree can just be made out at the end of the road in the distance.

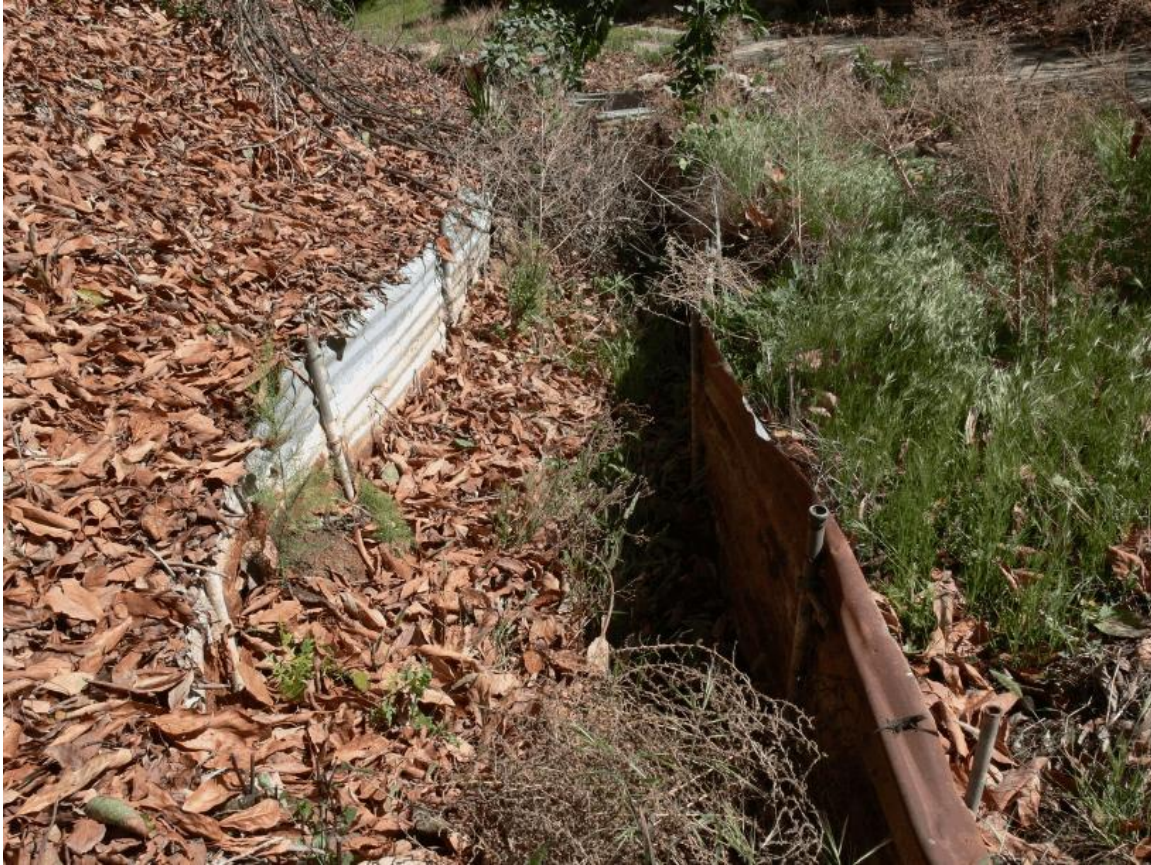
Drain A (photo 4): Looking north showing the metal corrugated sides of this part of the drainage and the high amount of leaf litter.

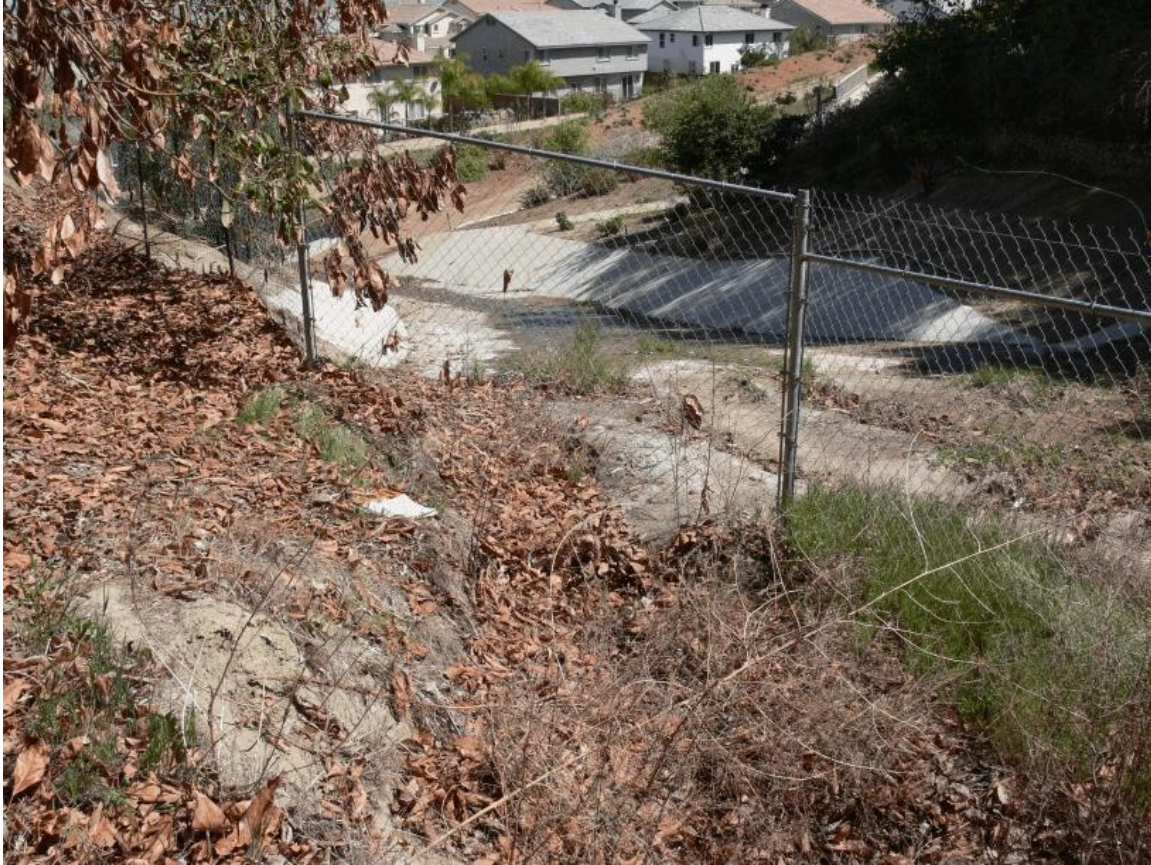
Drain A (photo 5): Location where Drain A leaves the site and enters cement lined channel to basin along north edge of subject property.

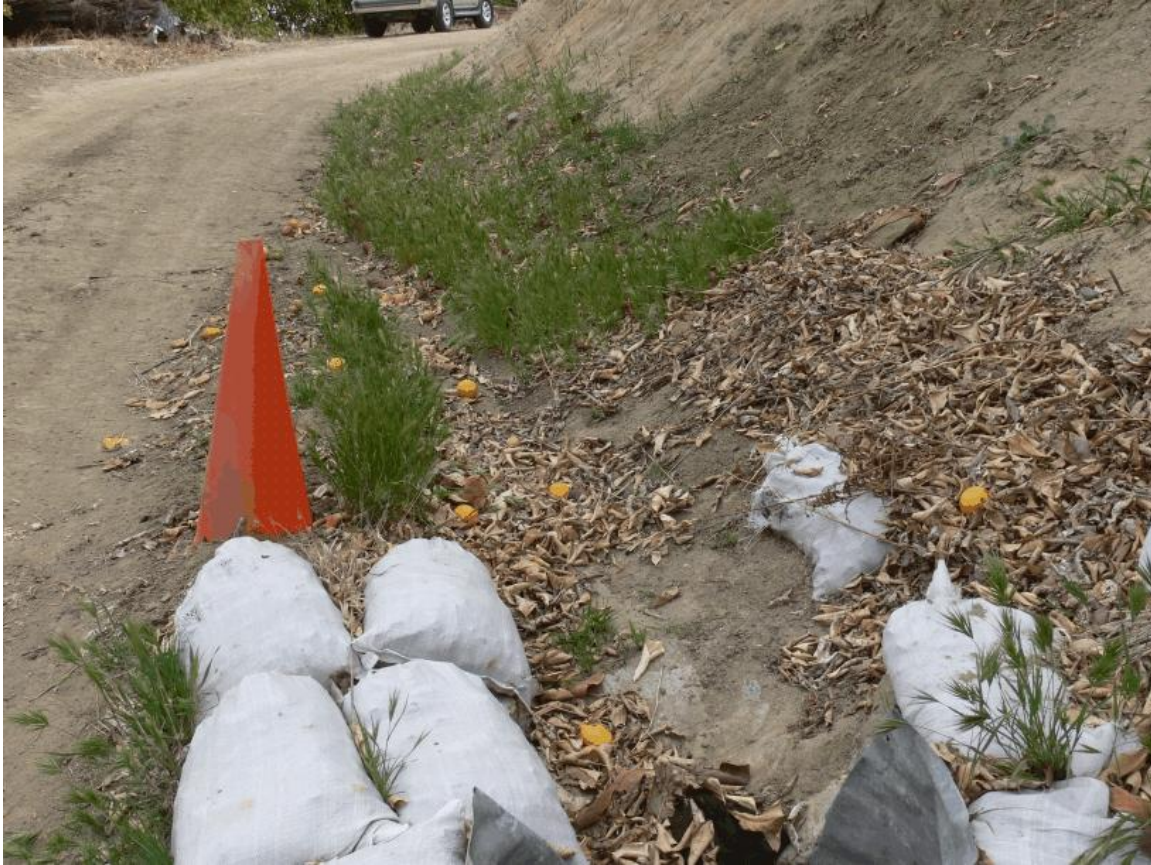
Drain A (photo 6): Head of side tributary to Drain A. Water runoff from road collected in pipe in foreground and piped down to lower road.

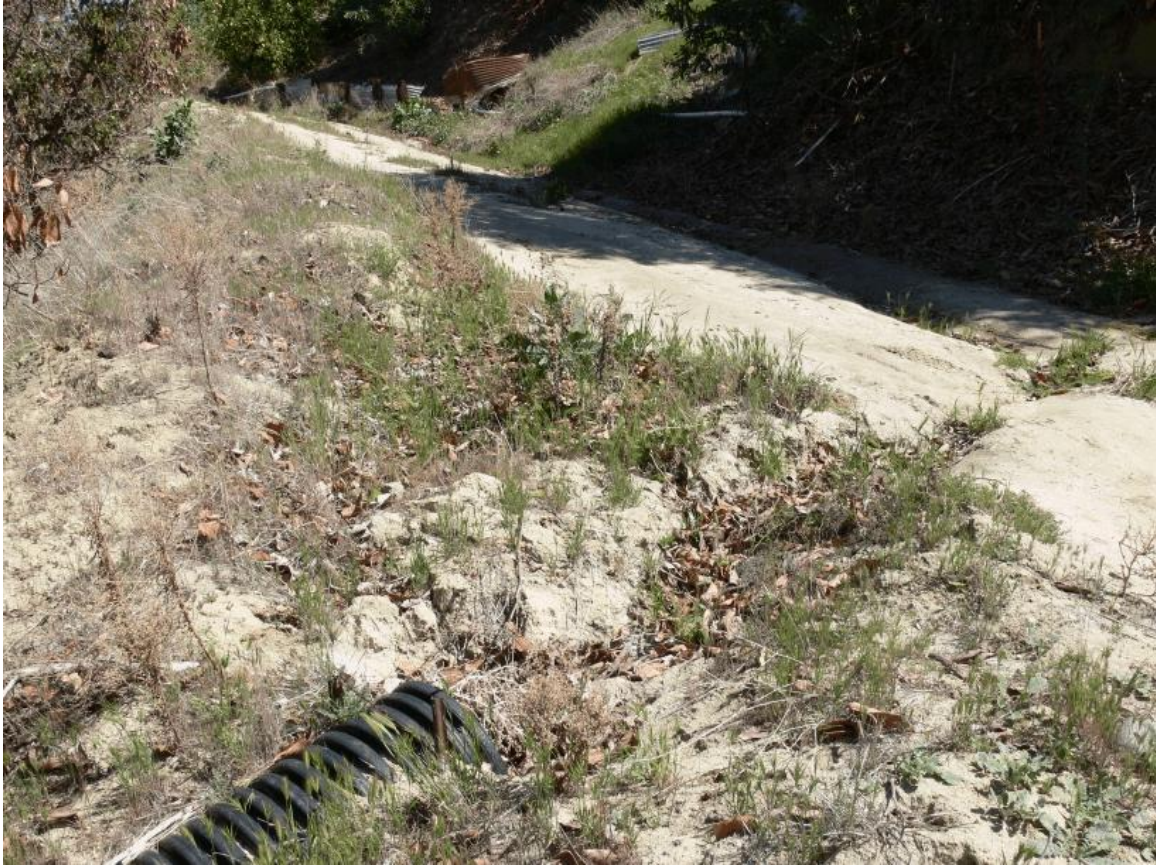
Drain A (photo 7): Pipe from previous photo empties into ditch along far side of this road, crosses the road, and empties into the pipe in the lower right corner of this photo.

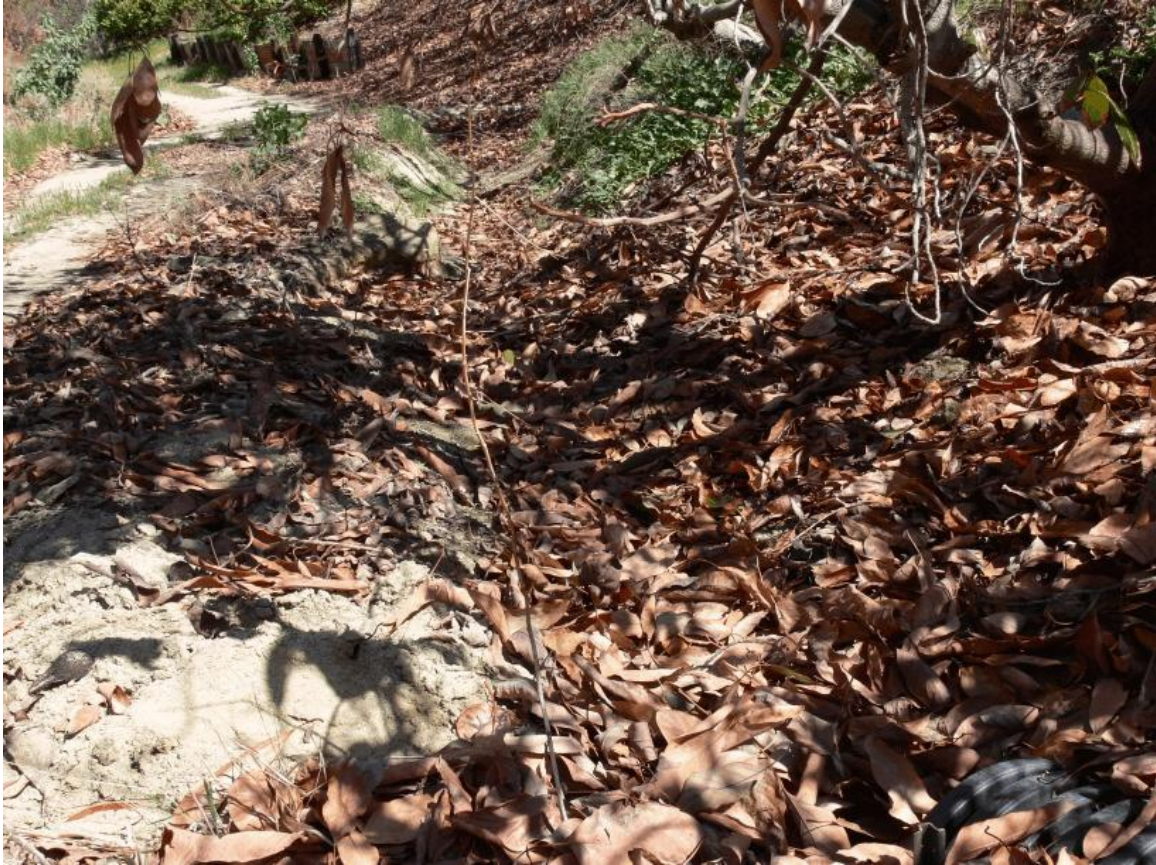
Drain A (photo 8): Drain exits from pipe in lower right corner of the photo into this leaf-filled ditch which it follows into a pipe that connects it to the main line for Drain A on the other side of the road seen in the upper left corner of this photo.

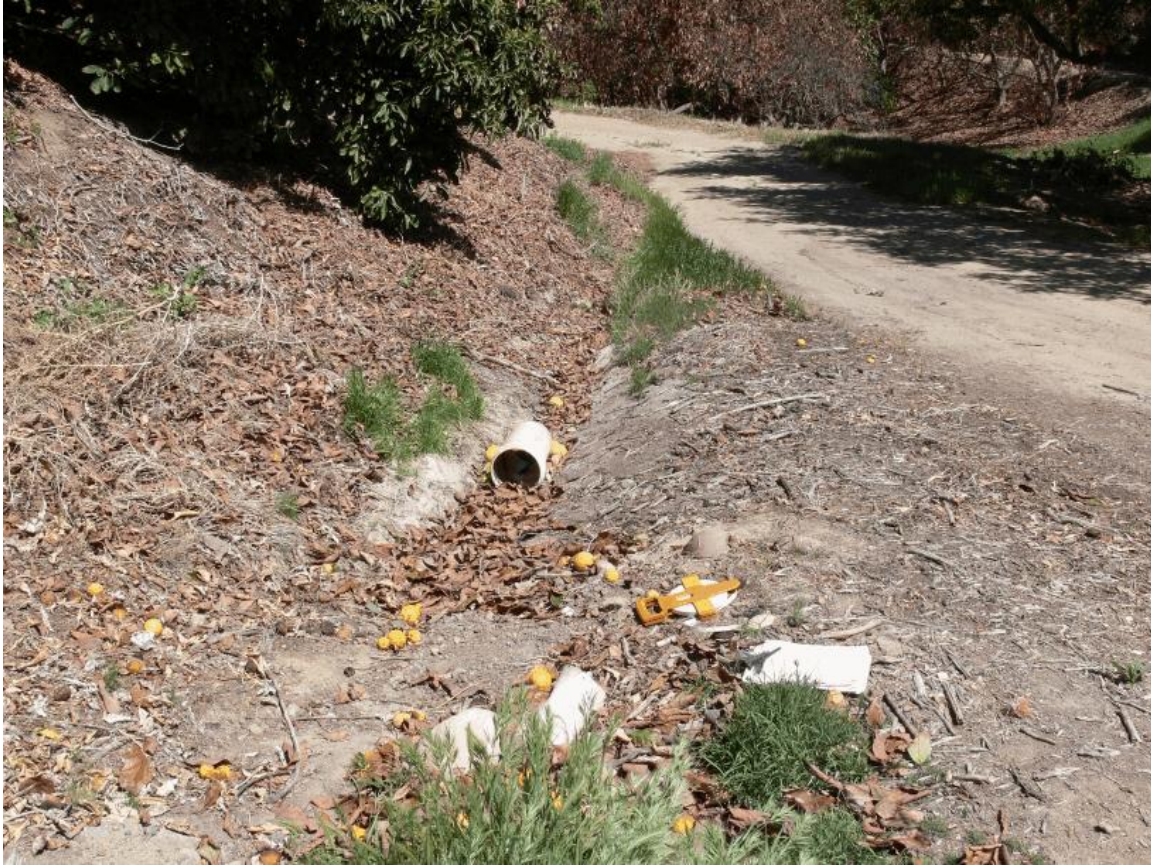
Drain B (photo 9): Head of Drain A looking to the north from the property border. This drain enters a pipe further down the road (just before where it leaves the photo).

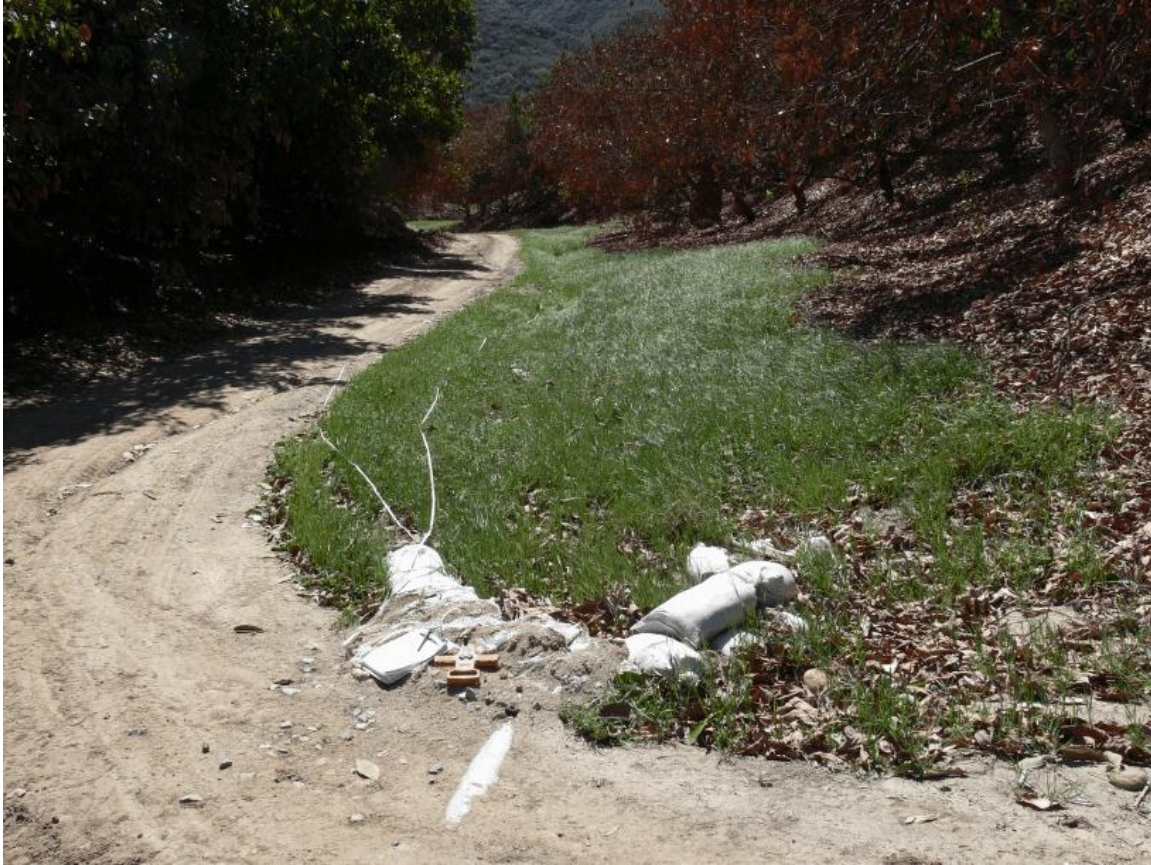
Drain B (photo 10): Looking south along the drainage from where it crosses under the access road (pipe partly exposed in the roadbed in the foreground). The tributary to this drainage connects about where the road bends in the distance. Conditions in the tributary are similar to those shown in photo8.

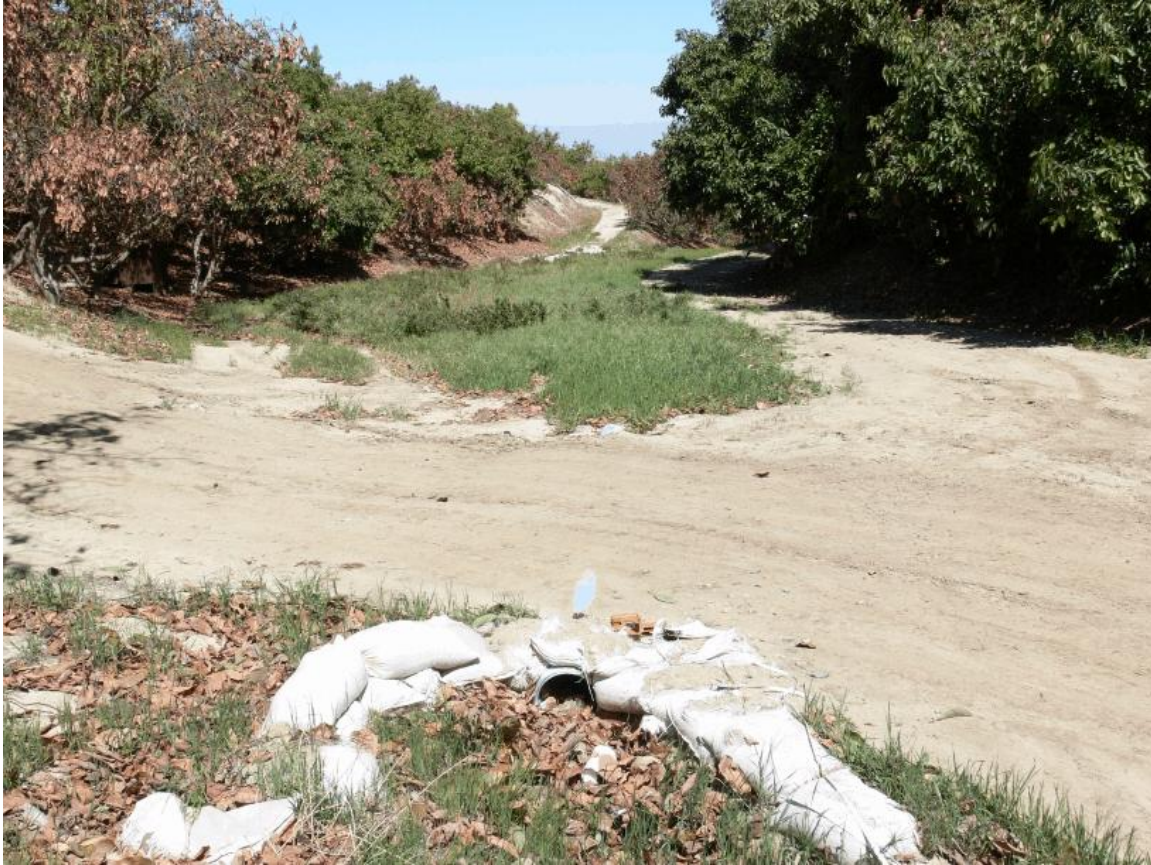
Drain B (photo 11): Looking north from just south of location of previous photo. Drainage passes through pipe under road into this grassy area before leaving the property.

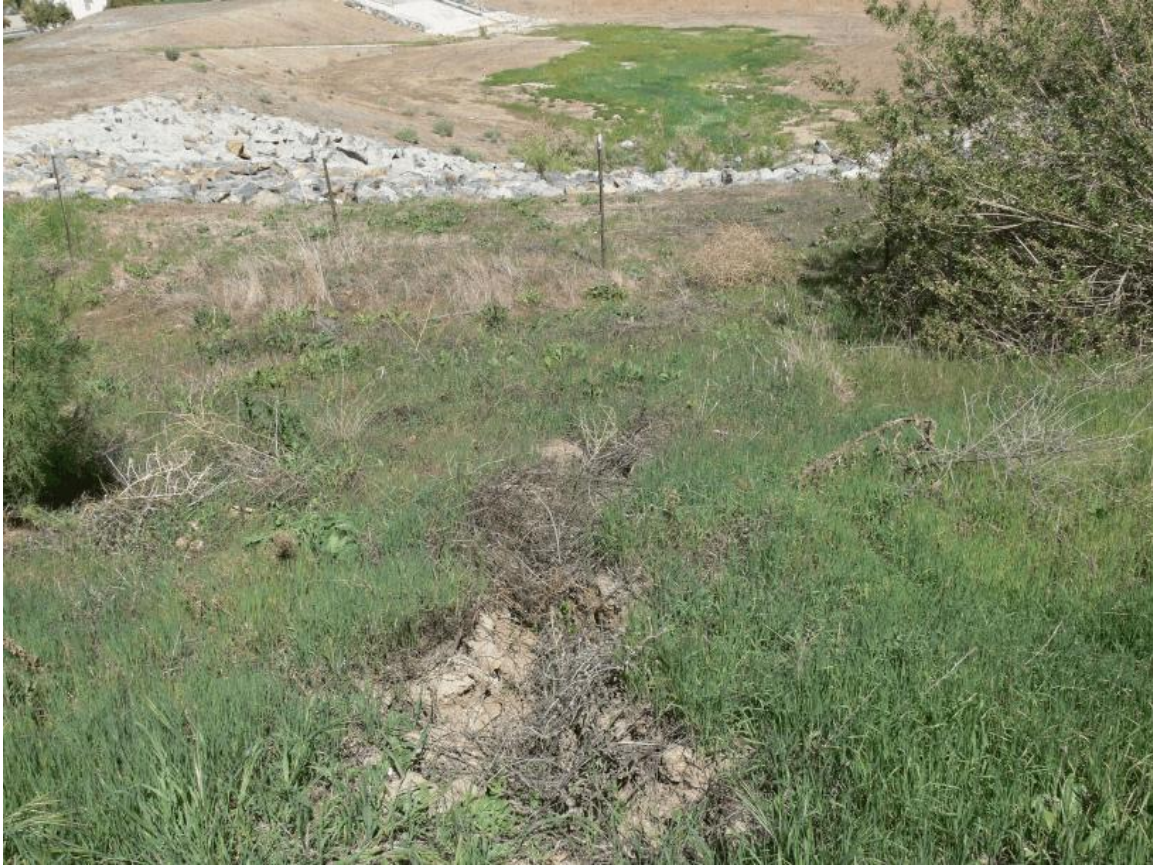
Drain B (photo 12): End of Drain B showing an incised drainage in the foreground. The chain-link fence in the background is the property border with a drainage basin beyond that.

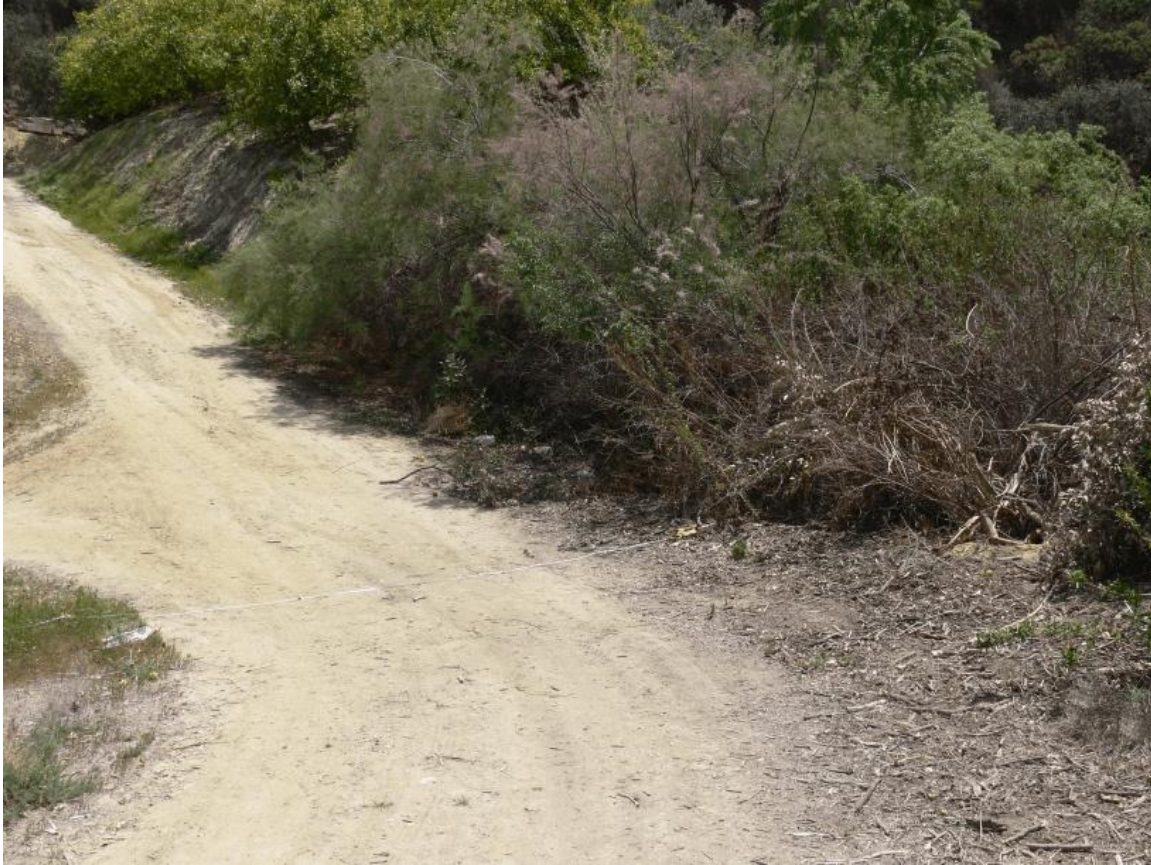
Drain C (photo 13): Drain C enters the property through a pipe under this road from the patch of mule fat on the right side of the photo. The white measuring tape on the road marks the approximate location of the pipe.

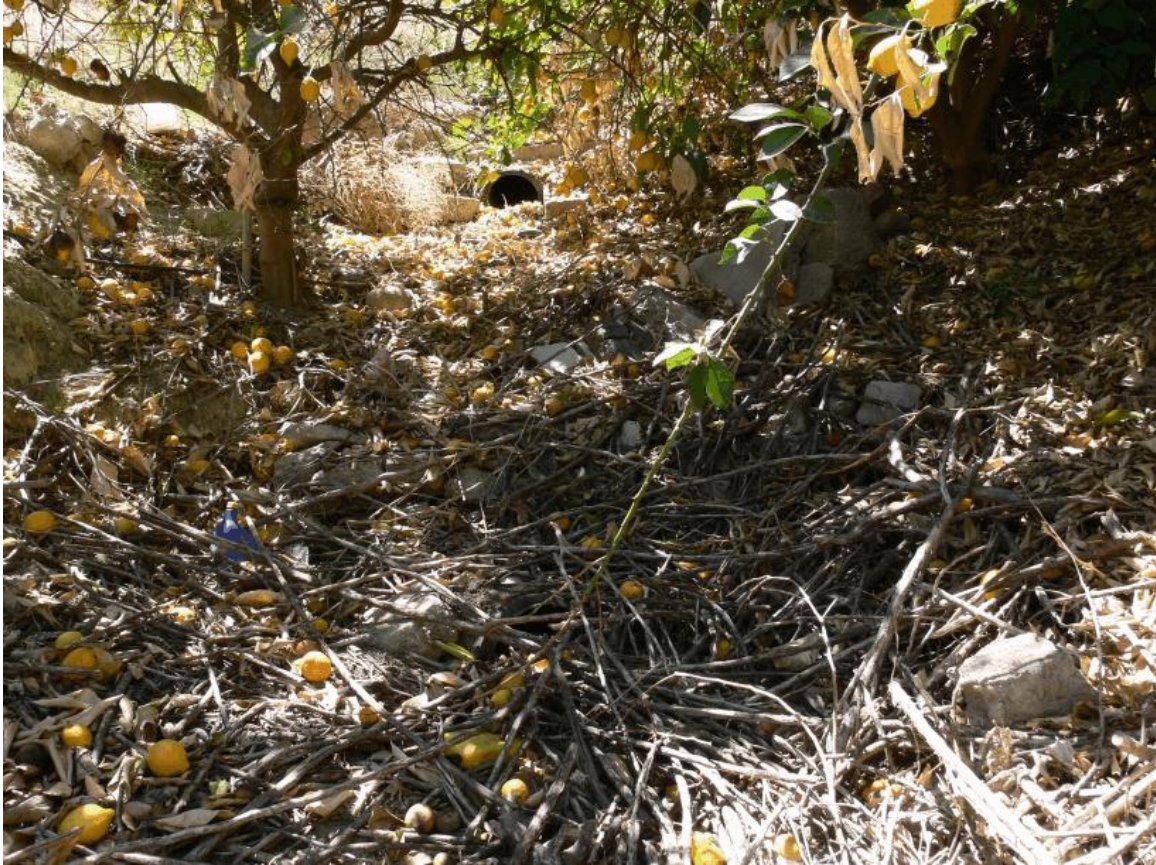
Drain C (photo 14): The pipe opening onto the property can be seen as the dark oval shape in the background of this photo taken looking to the south. The drainage passes through the center of a stand of lemon trees in a leaf and branch strewn path. The drainage passes through the lower left corner of the photo.

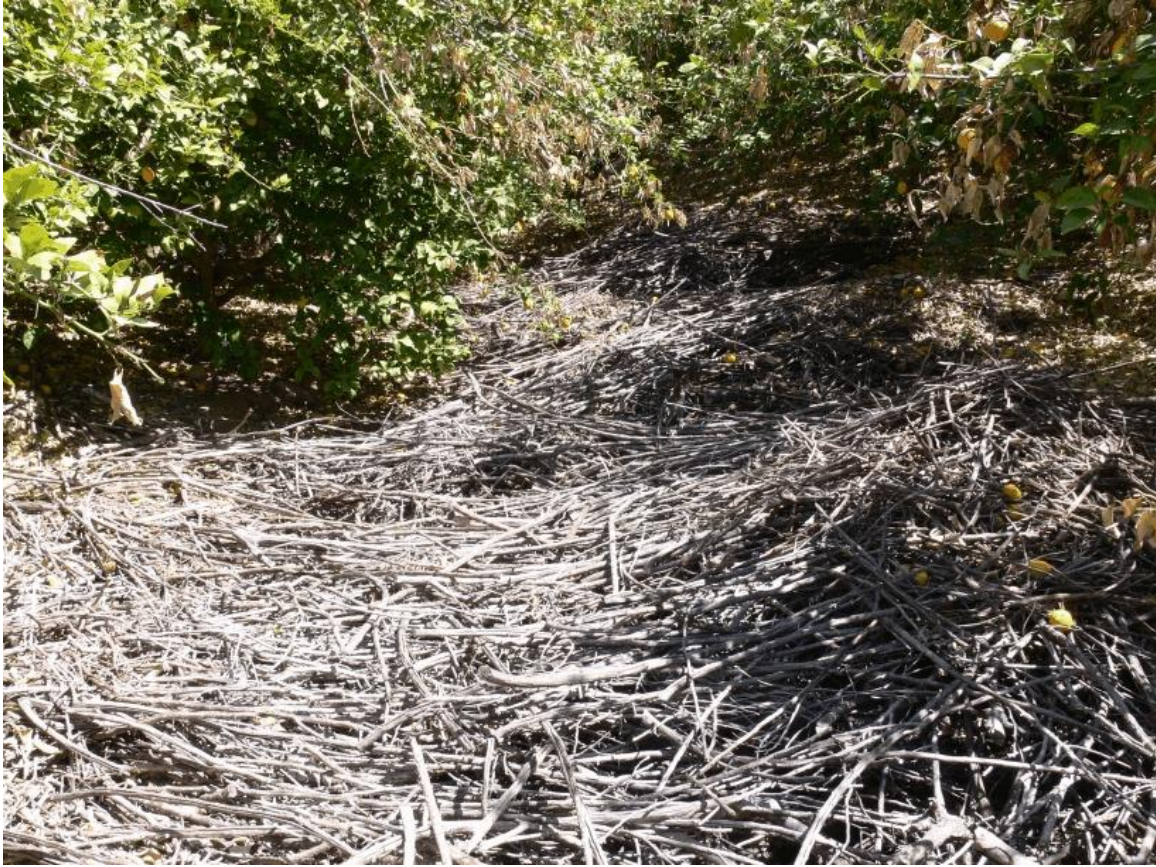
Drain C (photo 15): Pruned branches from the citrus trees have accumulated in the drainage as can be seen here. An incised drainage could be occasionally made out in the less dense areas along the course.

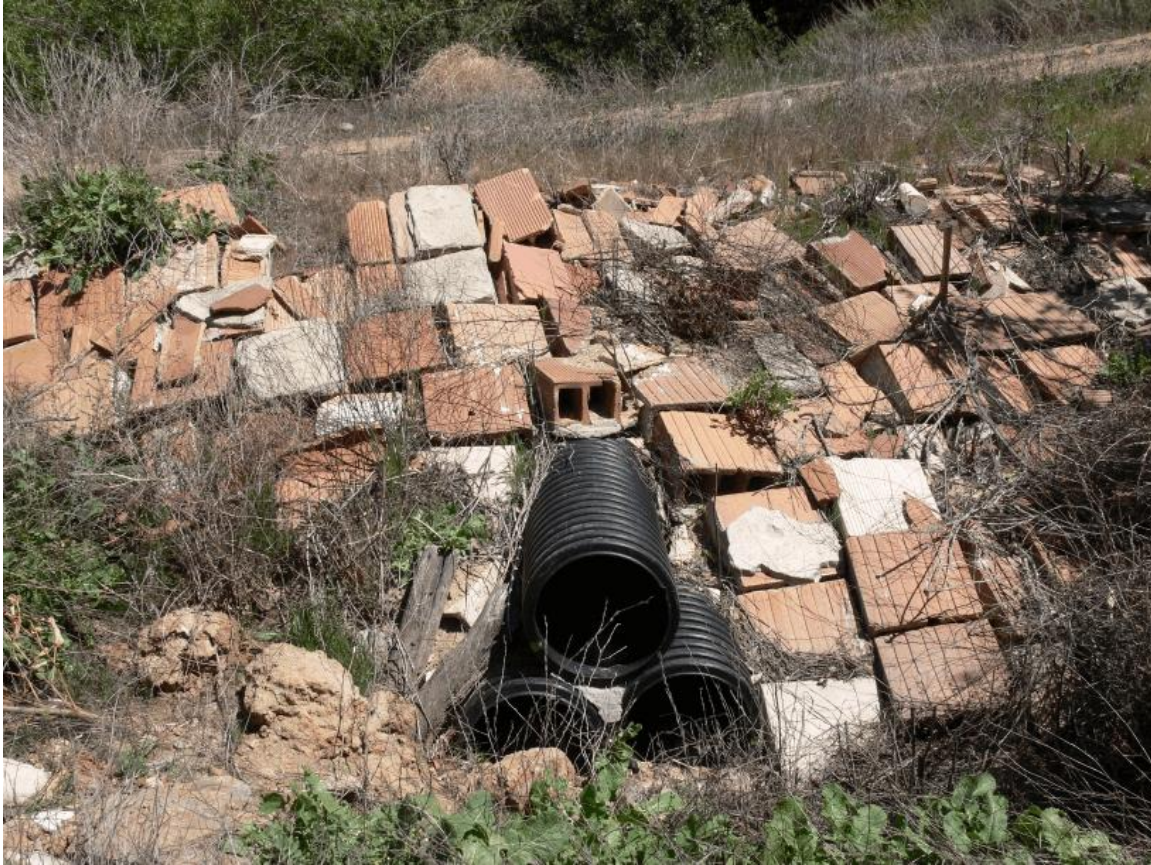
Drain C (photo 16): Drain C leaves the property through these pipes under the access road on the east side of the property.

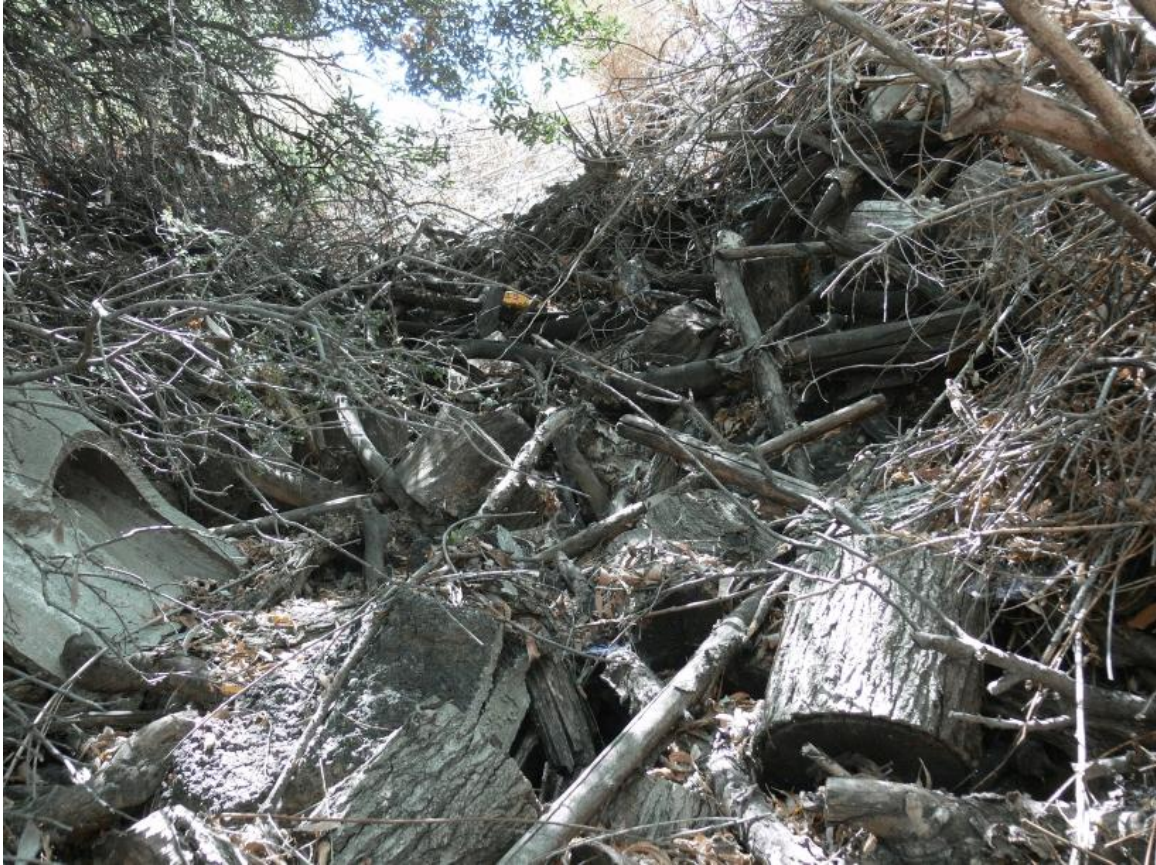
Drain C (photo 17): Beyond the access road, the drain runs down hill through this debris into the adjoining property.

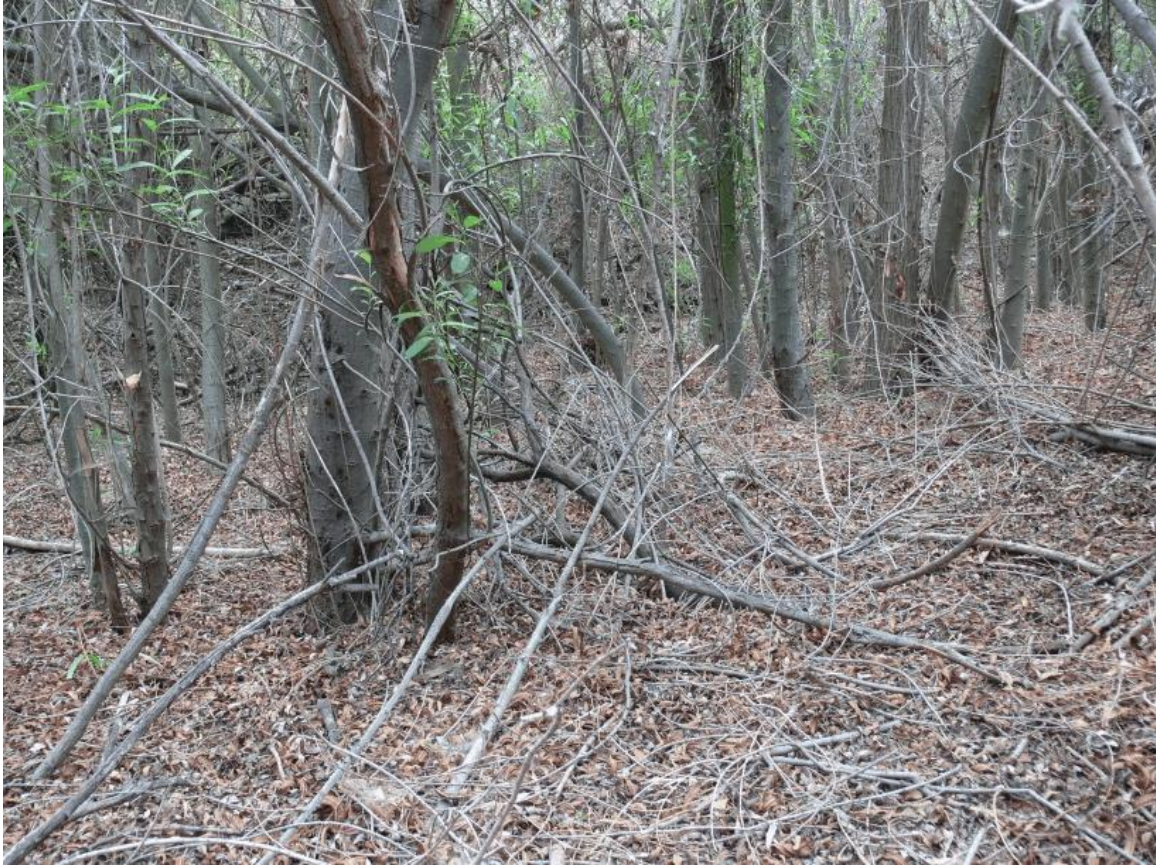
Drain C (photo 18): Off site, beyond the debris of the previous picture, the drainage enters this relatively flat area vegetated with a small patch of willow trees. No incised drainage was visible here.

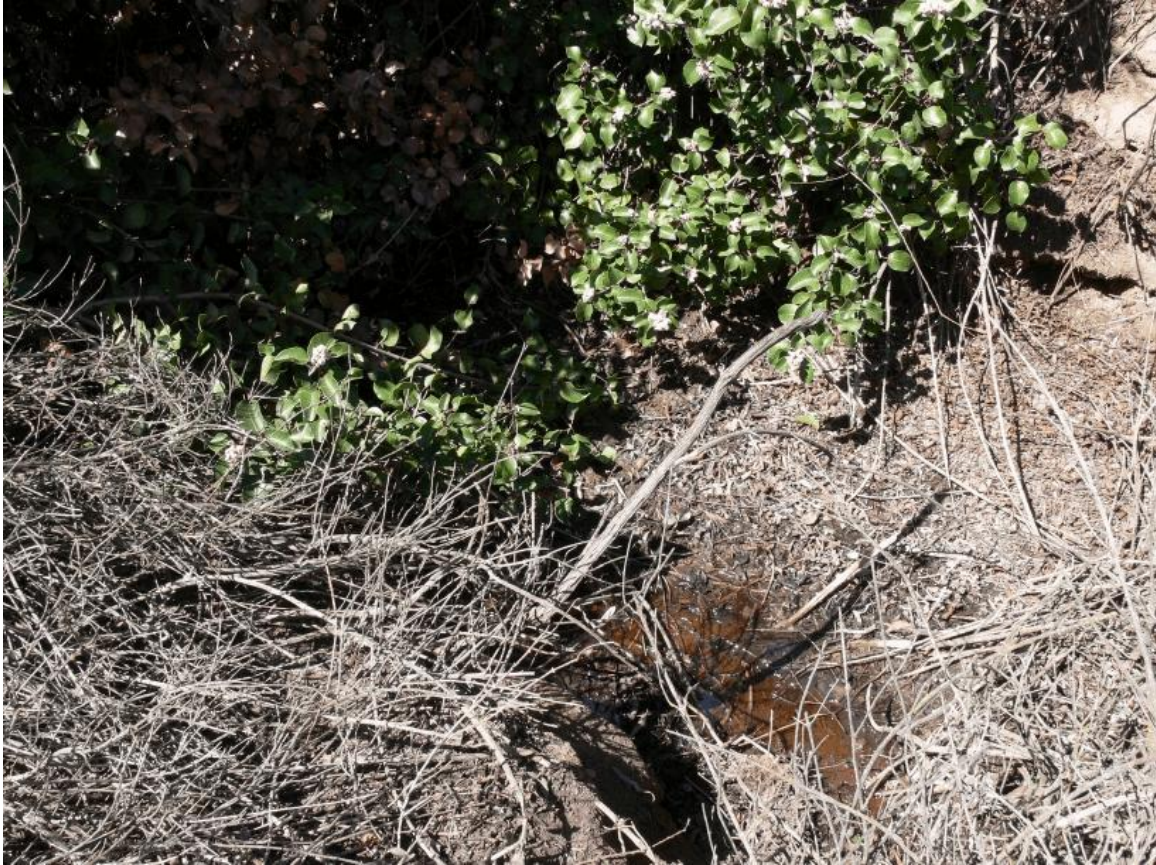
Drain C (photo19): Groundwater surfaces in a flat area just beyond the off-site willow trees.

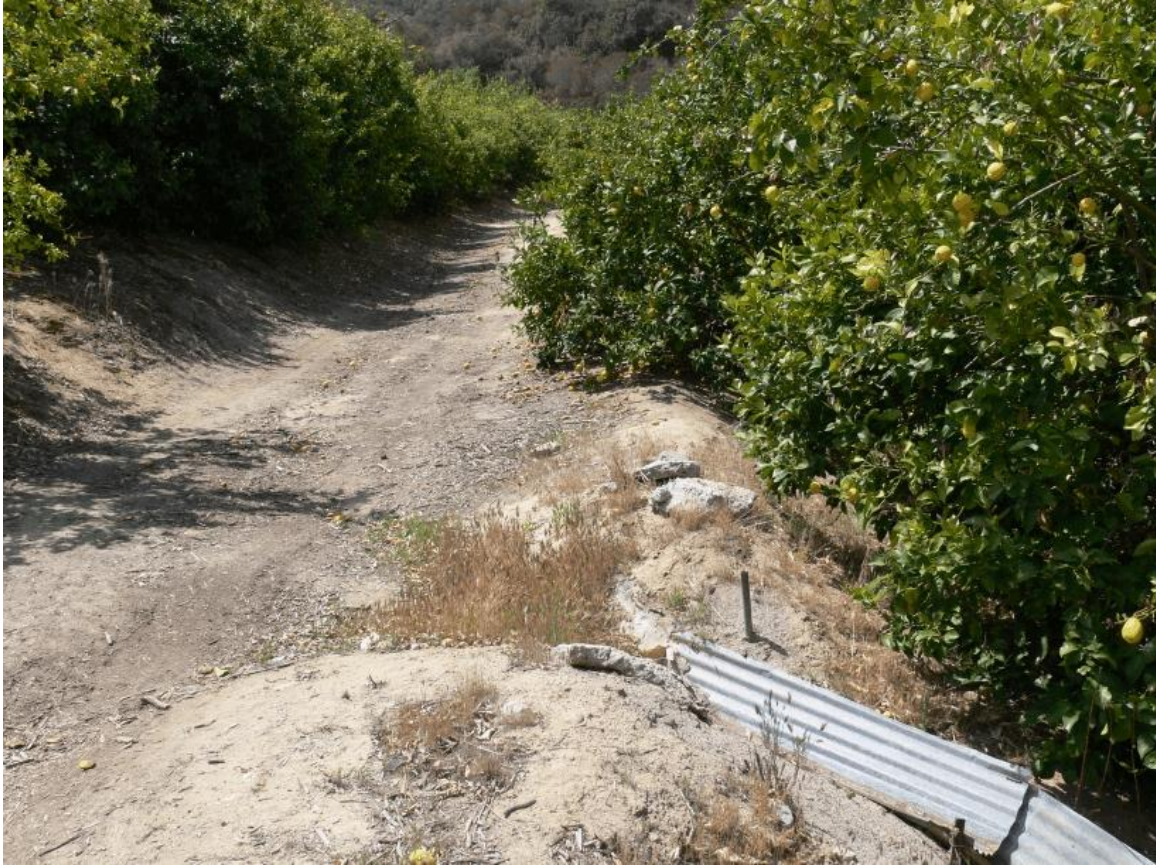
Drain C (photo20): The head of the tributary to Drain C. The tributary consists of a length of corrugated metal laid on the ground within the banks of an old drainage that collected road runoff.

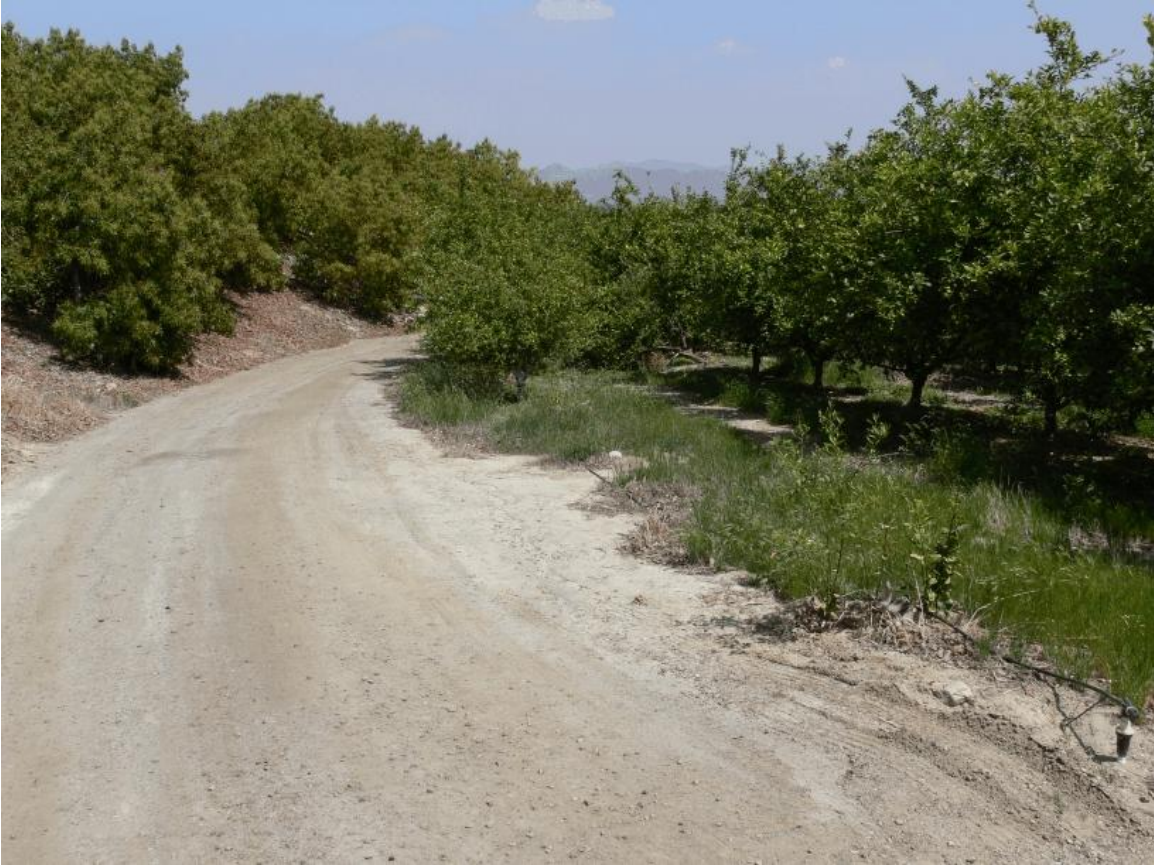
Drain D (photo 21): The head of Drain D begins to the right of the lemon tree next to the road near the center of the photo.

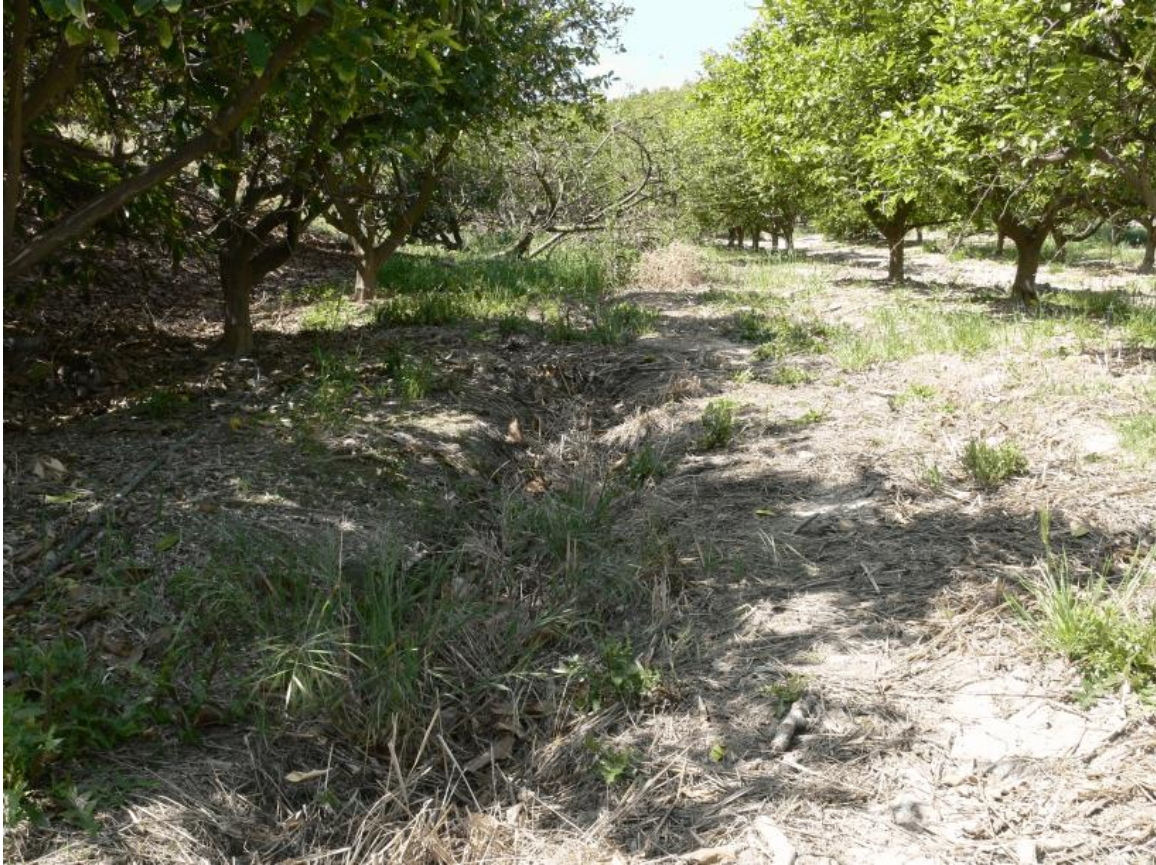
Drain D (photo 22): This photo shows typical conditions along one of the drainage branches that make up Drain D as it passes between rows of lemon trees.
