**JURISDICTIONAL DELINEATION
FOR TTM 34760 IN THE
CITY OF CORONA,
RIVERSIDE COUNTY, CALIFORNIA**

July 31, 2009

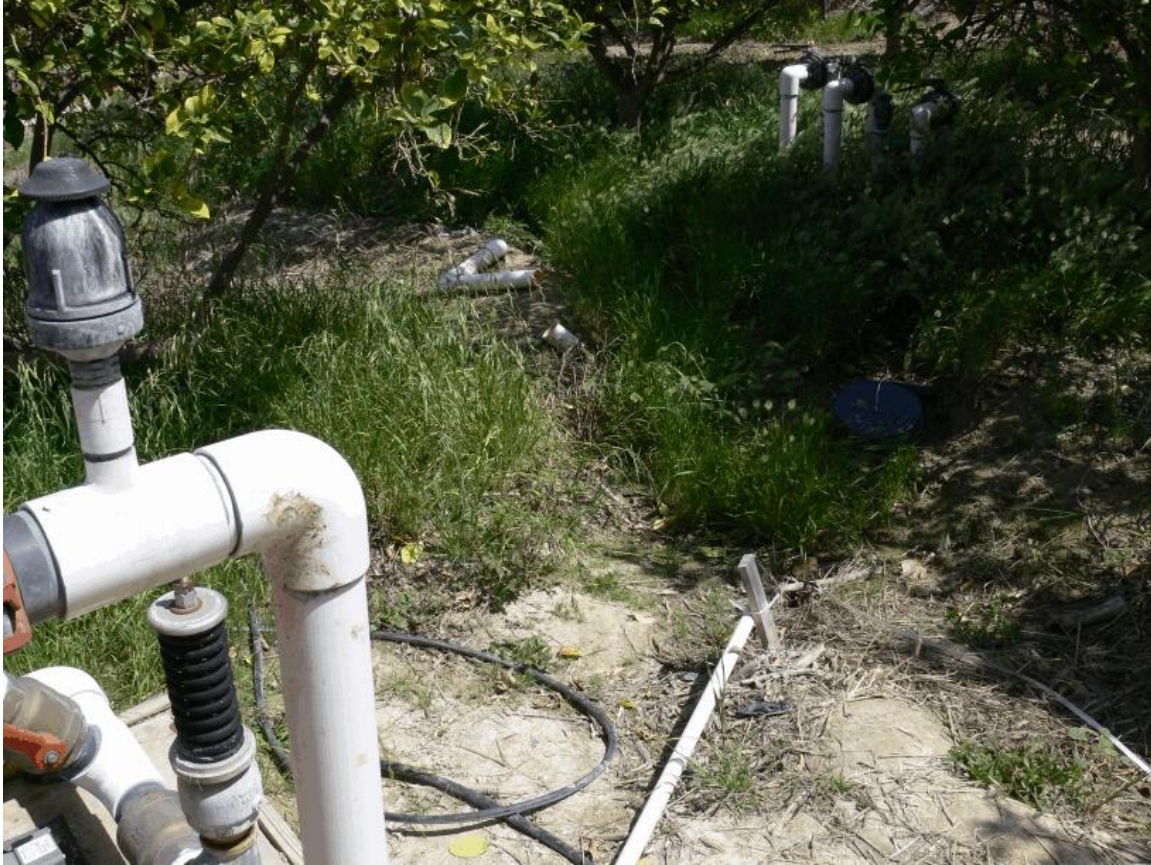
Drain D (photo 23): This photo shows the orchard water pump (left side of photo) and control valves (in the distance). The branch of Drain D nearest the main orchard access road can be seen passing between them. Water from the pump leaks into the drainage here.

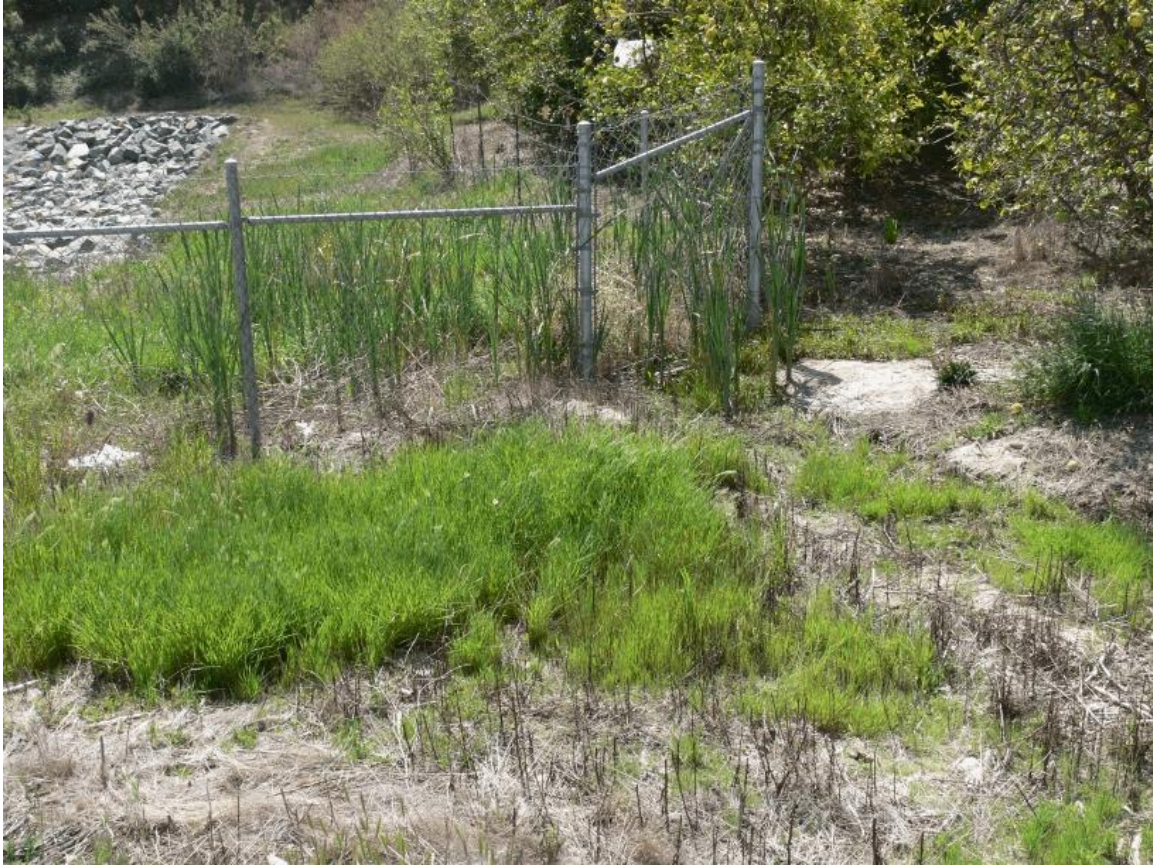
Drain D (photo 24): Drainage D leaves the site at this fence separating the subject property from the drainage basin beyond. Runoff from orchard irrigation has formed a wet area here and just beyond the fence.

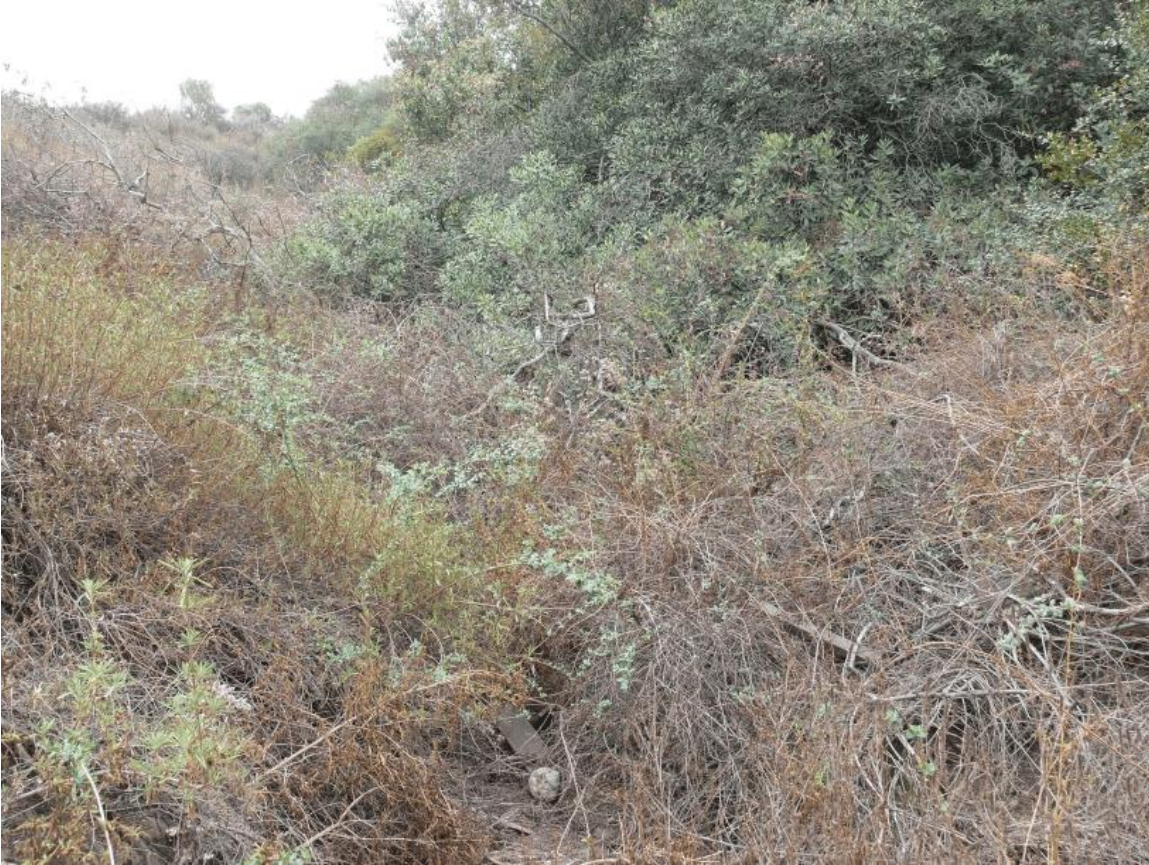
Drain E (photo 25): The head of Drain E begins in the brush to the upper left of this photo taken looking to the southeast. The round rock in the foreground marks the location where the drainage leaves the dense vegetation beyond.

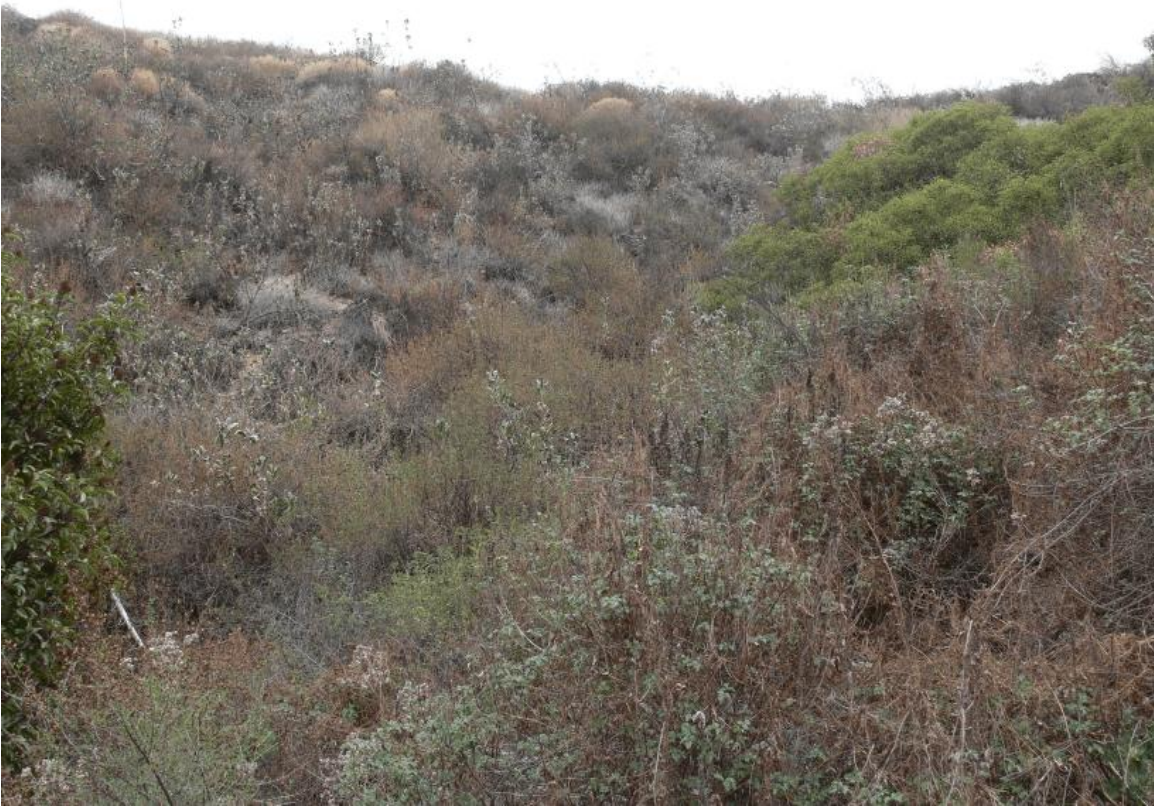
Drain E (photo 26): This photo was taken looking to the northeast showing the dense vegetation through which the side tributary to Drain E passes.

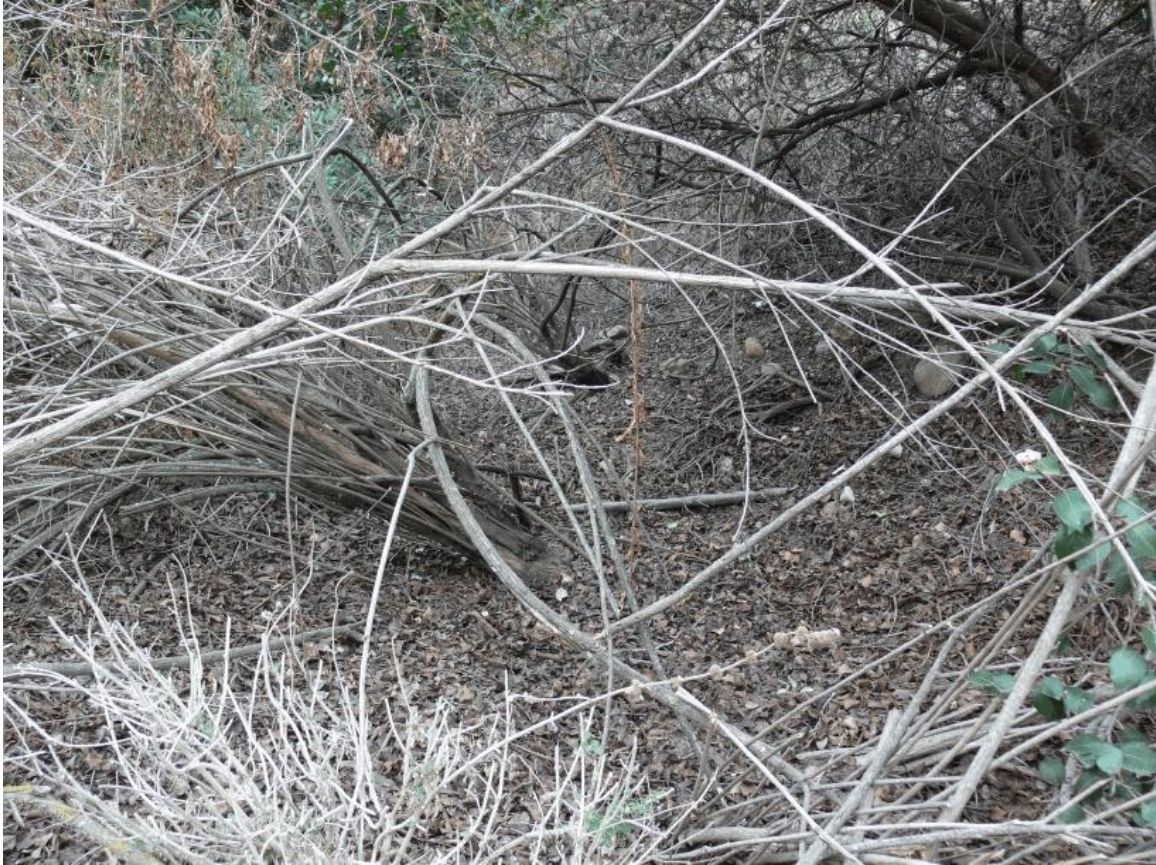
Drain E (photo 27): Looking to the southeast along the length of the drainage showing typical conditions.

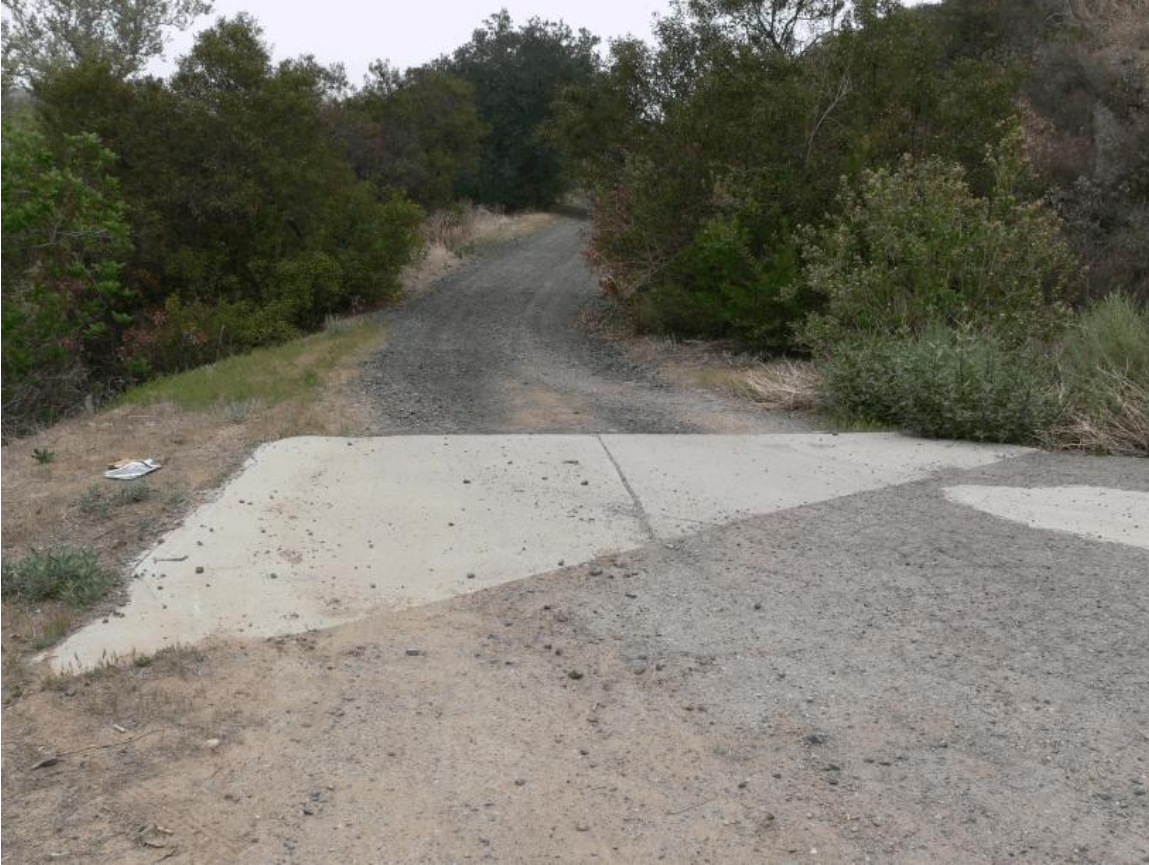
Drain E (photo 28): Looking northeast along the access road along the western edge of the project site. Drainage E passes under this road through a cement pipe from the bushes on the right side of the picture to those on the left side.

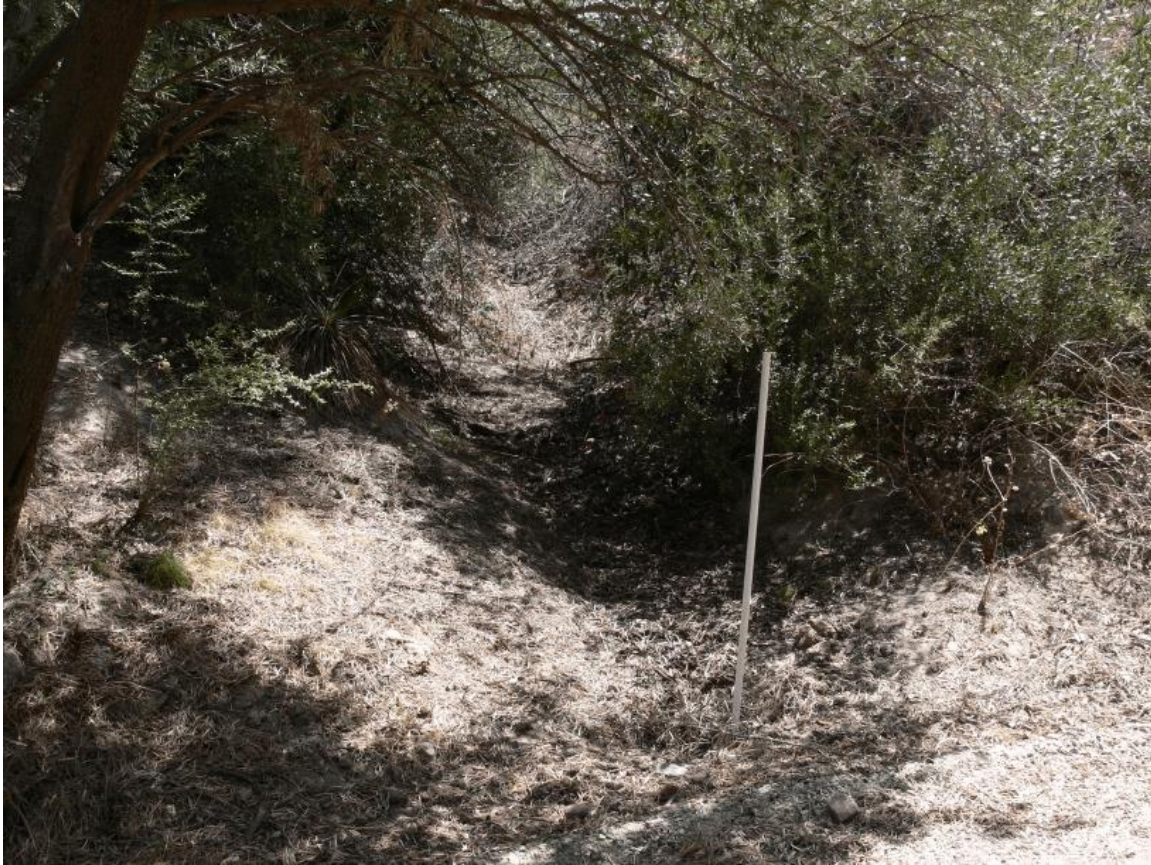
Drain F (photo 29): The point along the access road where Drain F leaves the site (at the white pvc pole). The drain comes downhill between a row of old olive trees (on the left side of the picture) and a shrub covered hill side (on the right side of the picture). The edge of the access road is just visible in the foreground.

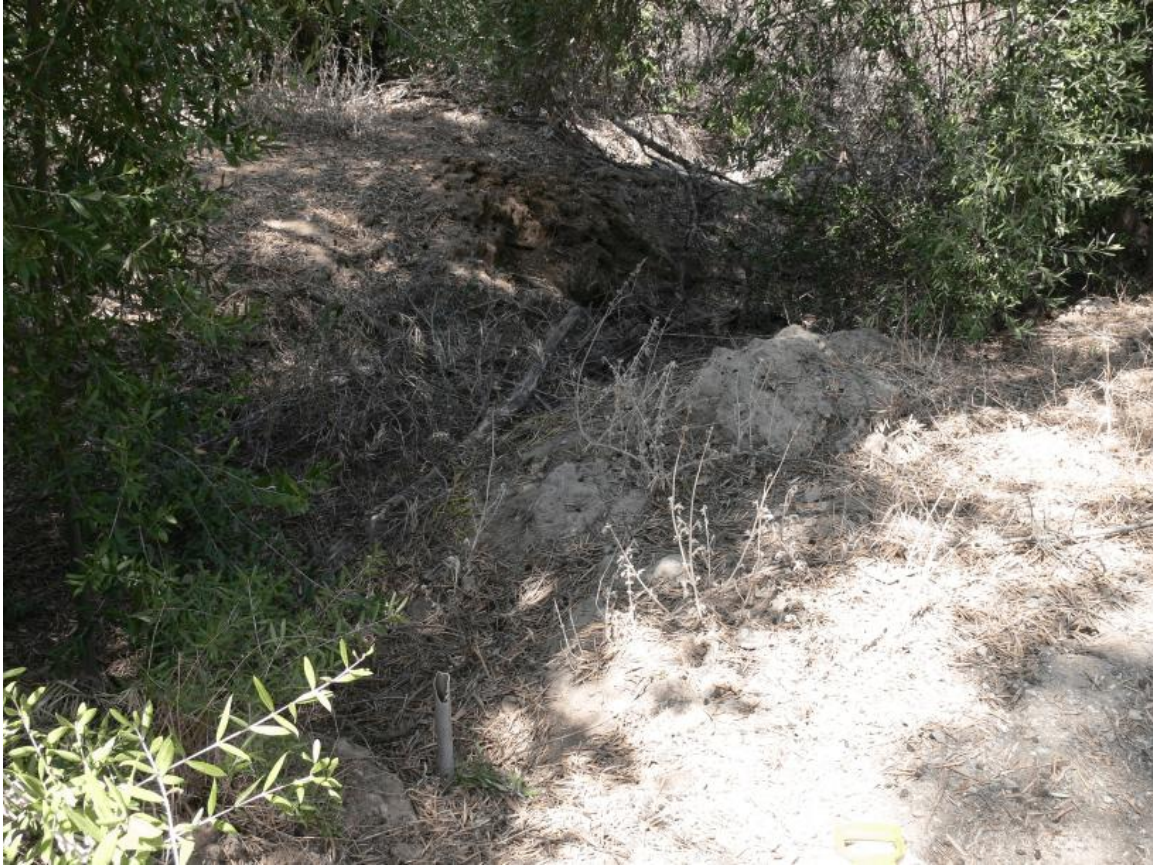
Drain F (photo 30): The drainage continues off site on the west side of the road (lower right corner of the photo).
