Appendix H-1: EIR-Level Geotechnical Study

***EIR-LEVEL GEOTECHNICAL STUDY
PROPOSED GREEN RIVER RANCH BUSINESS PARK DEVELOPMENT
SOUTHWEST OF GREEN RIVER AND DOMINGUEZ ROADS
CITY OF CORONA, RIVERSIDE COUNTY, CALIFORNIA***

Subject: EIR-Level Geotechnical Study, Proposed Green River Ranch Business Park Development, Southwest of Green River and Dominguez Roads, City of Corona, Riverside County, California

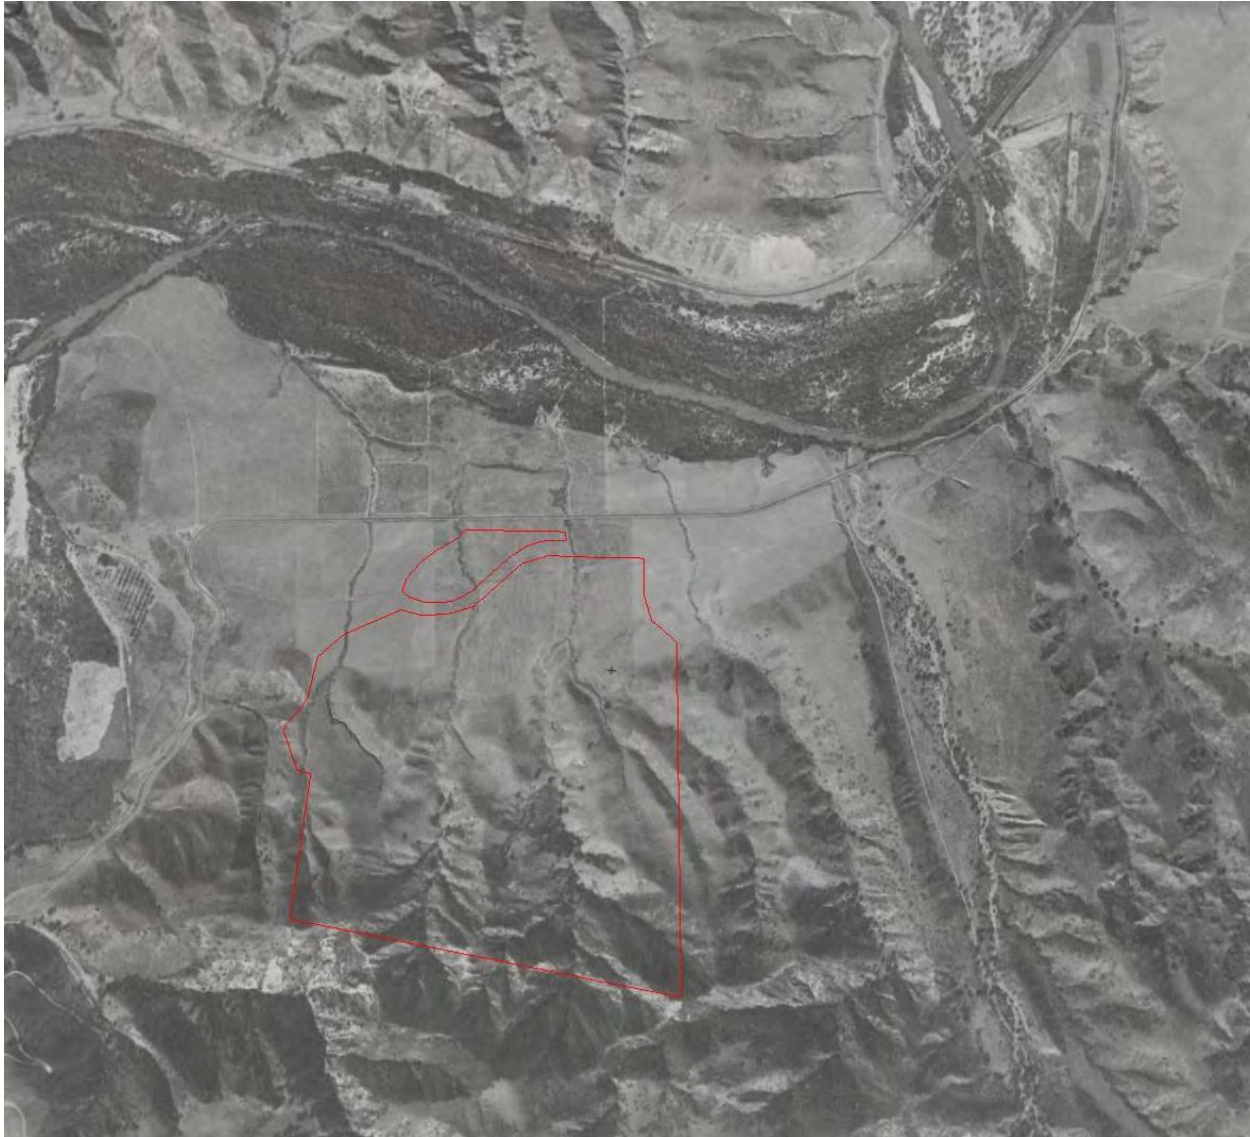
Figure 2 – Portion of Frame A-15, from Flight C-388, year 1928, with specific plan property boundaries approximately located. Land use appears to be minimal.

Frame A-15 from Flight C-388 available from the UCSB collection is shown below in Figure 2. The primary land use may be agriculture or vacant land in 1928. In the photographs from 1938 the site appears not to have experienced any flooding from the Santa Ana River channel. By 1967 the land still appears to be generally vacant, however a few small structures appear to be present in the northeastern part of the site. By 1980 the horse operation begins to appear with a few corrals and stock tanks.

There was no visible evidence of faulting in the air photos of the site to be currently developed (Parcels 1 through 5). The site geology appears to be dominated by the flood plain deposits that form the lower base of the flatter terrain at the base of the southern hills, with an additional older terrace on the hills above.

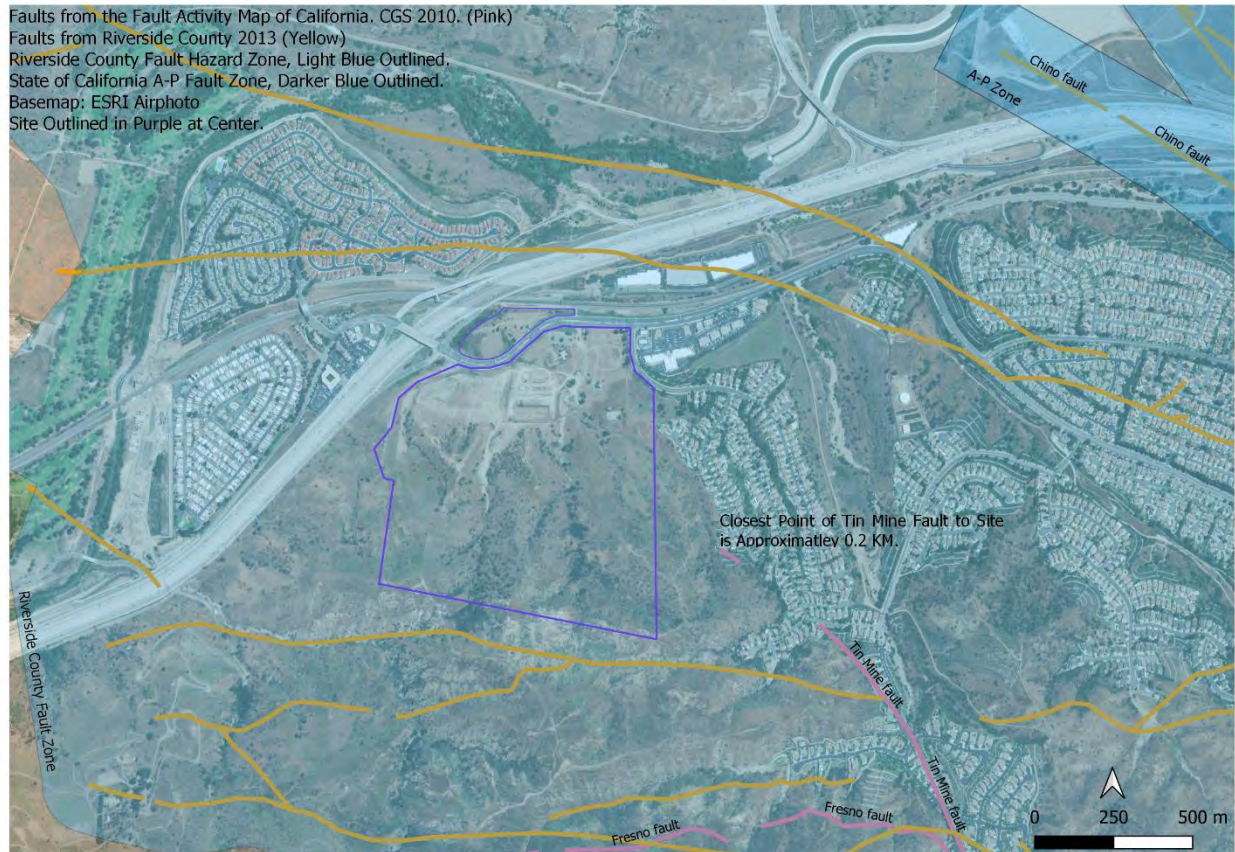
Figure 9 – Riverside County Mapped Faults and Fault Zones

On the basis of our review of the current revision of the Technical Background Report of the City of Corona for the draft General Plan update, no active faults have been identified within the site boundaries. However, the City has shown designated zones wherein additional subsurface investigation may be required to determine the presence and level of activity of suspected active branches of local fault systems based on the Riverside County mapping, (City of Corona Planning Division, 2020). This is shown on Figure 5-1 of the draft Technical Background Report. The site in relation to faults and fault zones of Riverside County is shown on Figure 9.

The results of all of the various sources of maps for faults do not indicate any faults onsite. The site is not located within a state designated fault zone; however, it is within a zone designated by the county. Further detailed studies could be required at the design level by the City.

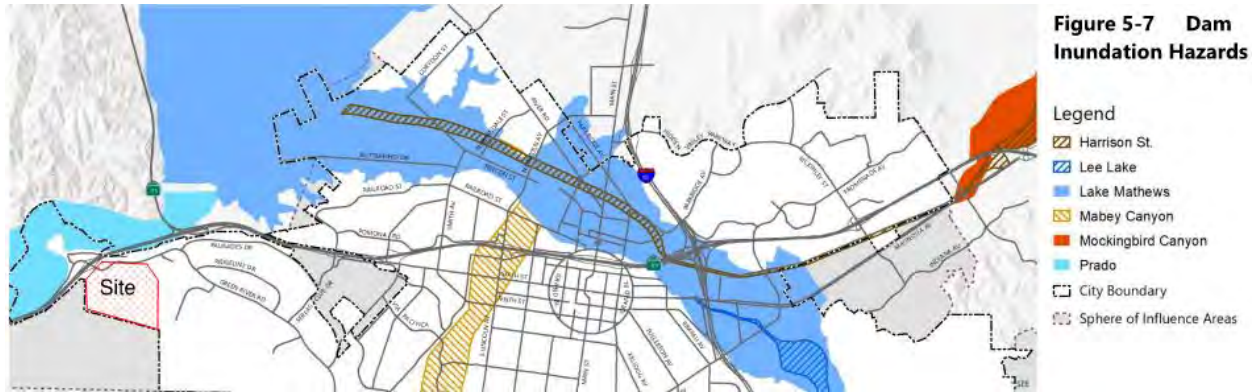
Figure 10- Portion of Figure 5-7 from the General Plan Update – Technical Background Report, the site is shown on the left.

One major flood control dam lies upstream of the site - Prado Dam (1.3 kilometers to the northeast). In the event that a seismically-induced failure of the Prado Dam facility was to occur when this dam basin was filled to capacity, most, if not all, of the resulting flood waters would be expected to be discharged within the Santa Ana River. The flood inundation maps prepared by the Army Corps of Engineers do not indicate that a failure of the Prado Dam could cause extensive flooding within the site (U.S. Army Corps of Engineers, 1985).

The potential for seismically induced flooding within the boundaries of the City of Corona in the Technical Background Report. The location of the site is shown on Figure 10 below.

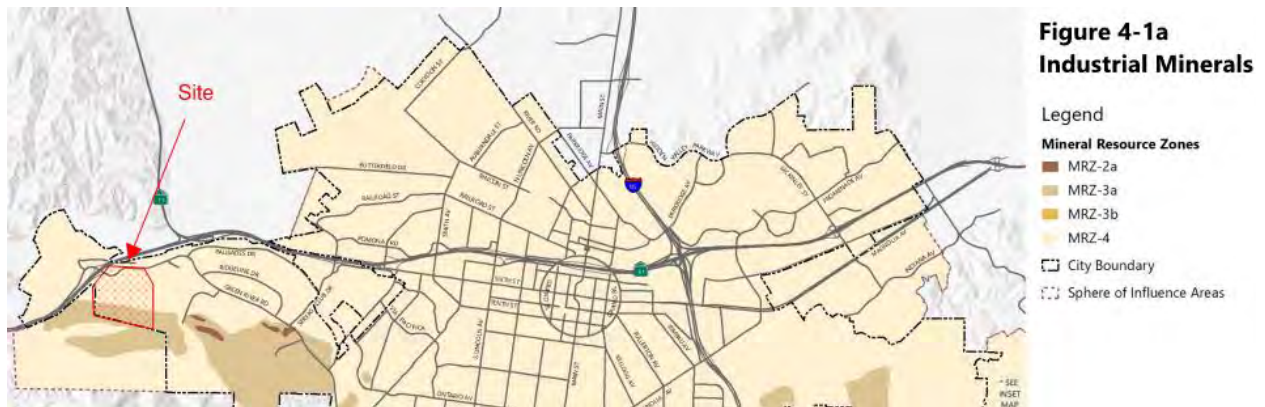
Figure 13 – Portion of Figure 4-1a from the Technical Background Report showing Mineral Resources, A portion of the site along the southern side is within an area designated at MRZ-3a.

The state and the city have mapped the general area for significant mineral resources. The city mapping indicates there are some useful mineral resources potentially present onsite. The location of the site and identification of the type and approximate location of mineral resources is shown on Figure 13 below.

MRZ zone are classified into 4 categories, with MRZ-3 classified as “Areas of Undetermined Mineral Resource Significance” with the additional subclassification for zone MRZ-3a as “Known Mineral Occurrence.”
